FLUX EFFECT ON THE RADIATION DAMAGE OF AUSTENITIC STEELS

Hygreeva Kiran NAMBURI (CVR)

Centrum výzkumu Řež s.r.o.
Research Centre Rez

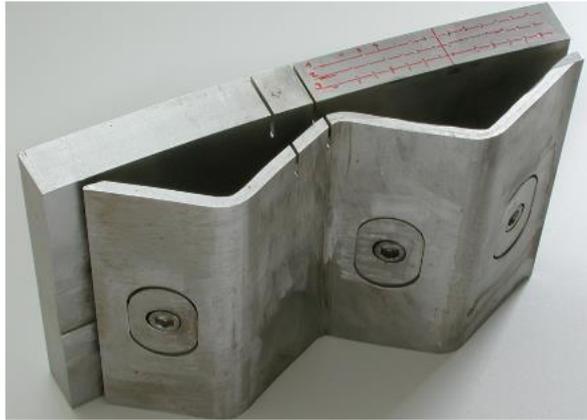
VVER-440 Nord /Greifswald Unit 1 Internal components – Ti stabilized austenitic steels
 Service 15 years , neutron flux $1-1.5 \times 10^{-8}$ dpa/s, high temperature, demineralized water
Without Oxygen

Steel	18Cr-10Ni-Ti
Component	Core basket (rolled plate 32 mm)
Microhardness	363 ± 9
Grain size	40 μm
δ ferrite	1 %
Irradiation T	320 °C
Dose	5.2 dpa
Irradiation time	15 FPPY

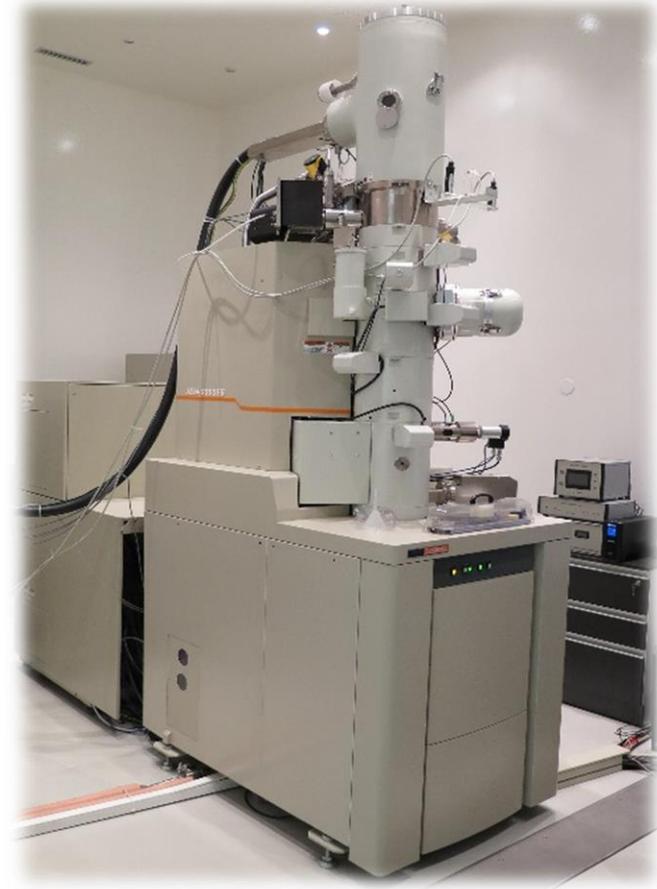
High Resolution Scanning Transmission Electron Microscope (HR-STEM), JEOL JEM 2200FS

- ❑ Electron source: Field Emission Gun (FEG)
- ❑ Accelerating voltage: 200 kV
- ❑ In-column Omega filter
- ❑ CTEM, STEM
- ❑ HAADF STEM detector for Z-contrast imaging
- ❑ EDX detector 80 mm²
- ❑ EELS
- ❑ Electron Energy Filtering EFTEM for high contrast, high resolution and chemical analysis
