IRRADIATION EFFECTS ON MICROSTRUCTURAL EVOLUTION

Grace Burke, University of Manchester

Wade Karlsen, VTT

Microstructural Characterization of Proton-Irradiated Type 316L SS

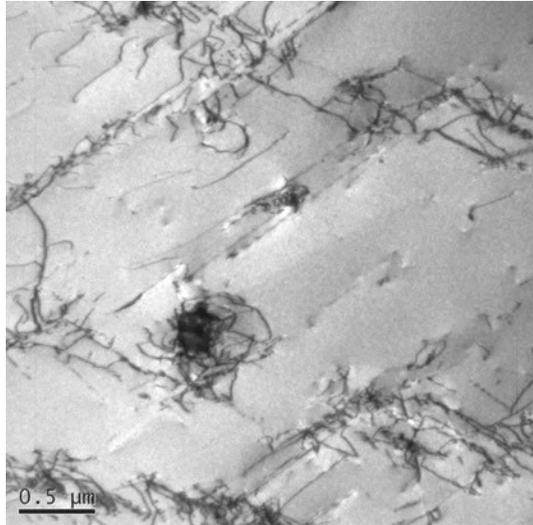
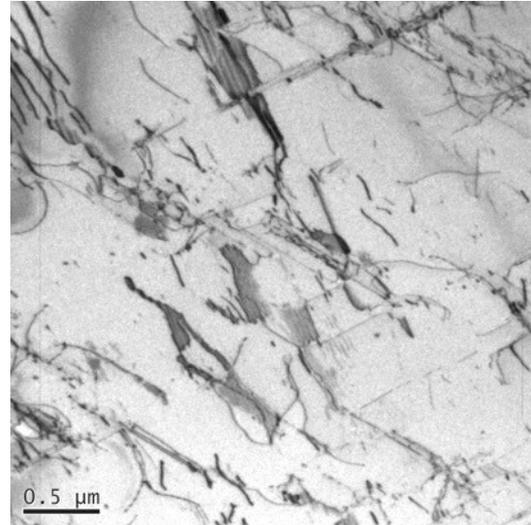
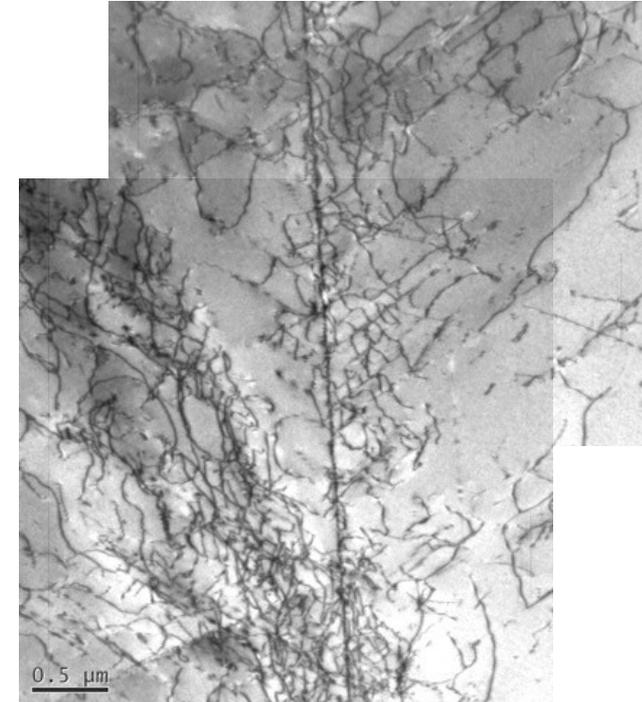
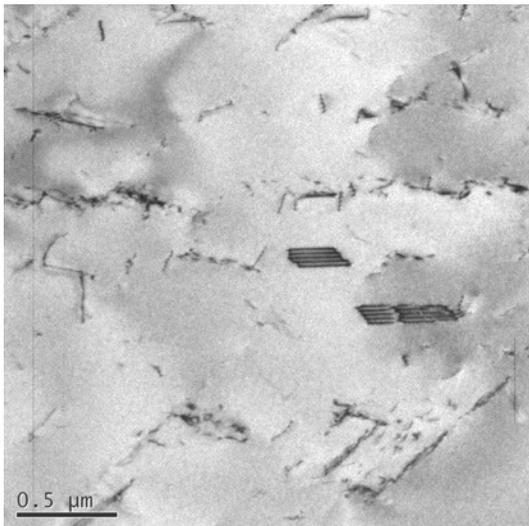
Non-Irradiated 316L SS: TEM

- ❑ General microstructure: Recrystallized grains; some evidence of intermediate T deformation (polygonization)
- ❑ No intergranular precipitation detected
- ❑ Numerous banded inclusions (complex silicates/MnS)

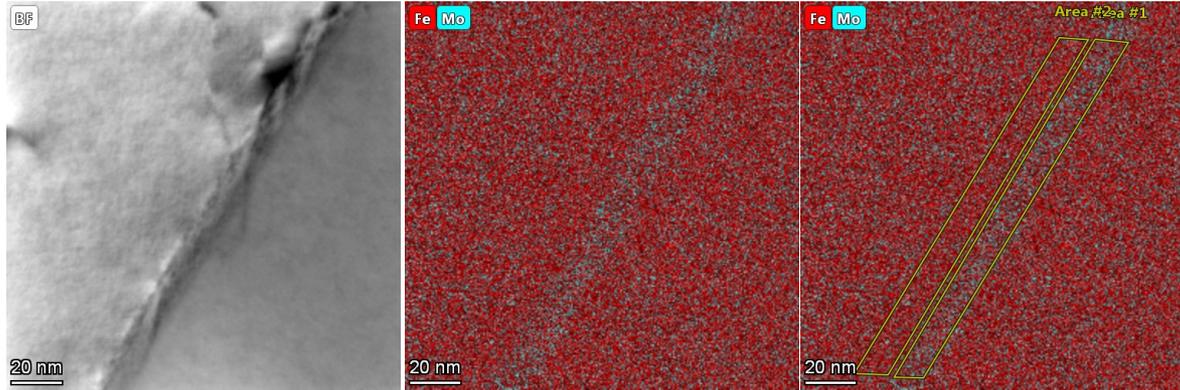
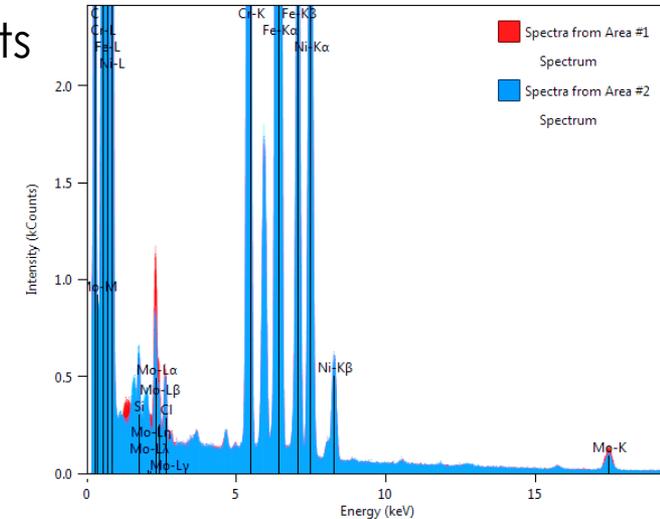
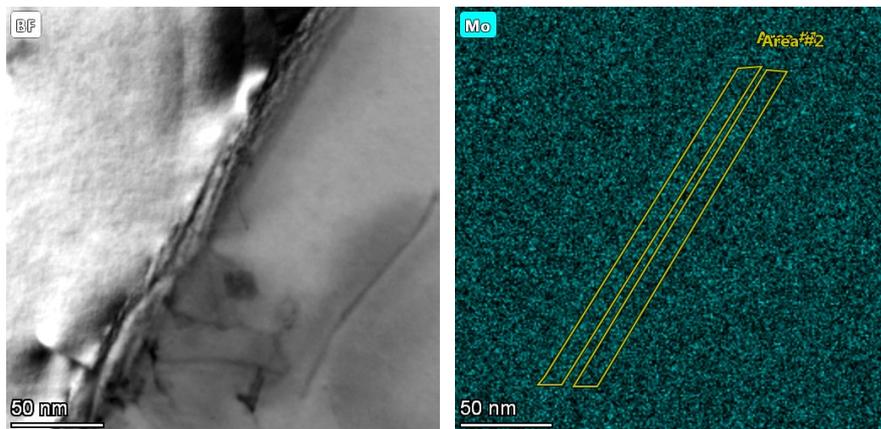
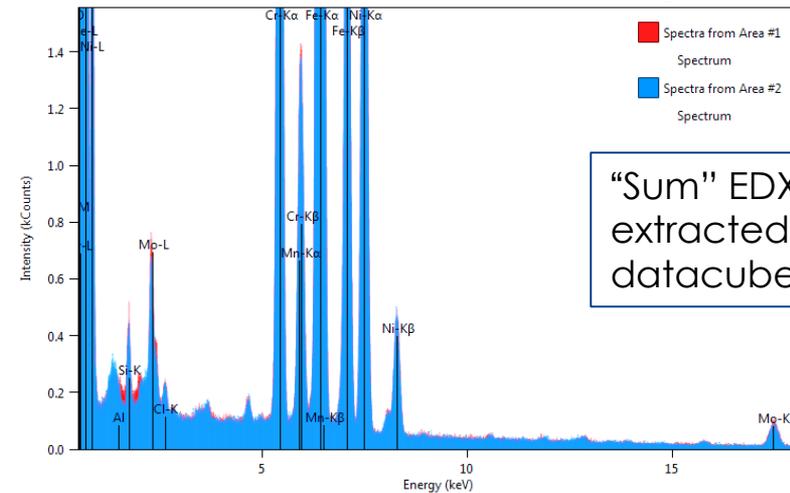
Non-Irradiated 316L SS: GB Segregation

BF STEM + Elemental maps from STEM-EDX SI Datasets

“Sum” EDX spectra extracted from SI datacube

- Inclined grain boundary: detectable Mo segregation in as-received condition (Consistent along grain boundary)

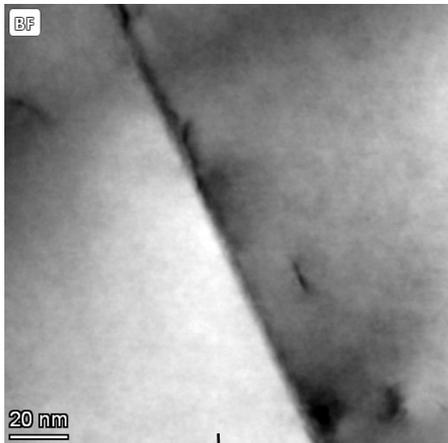
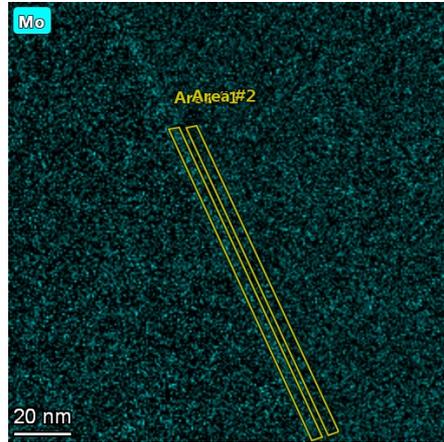
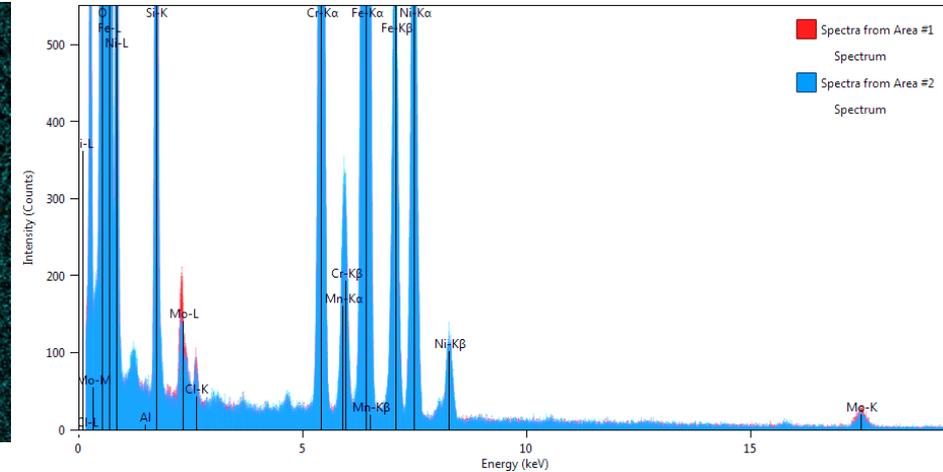
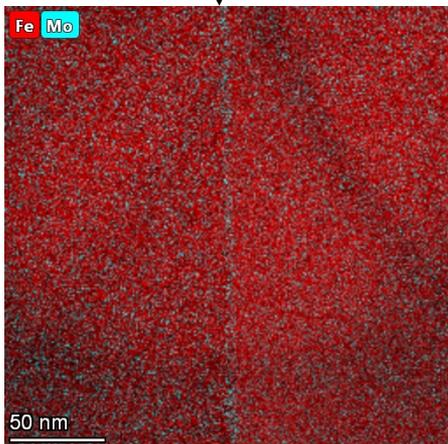
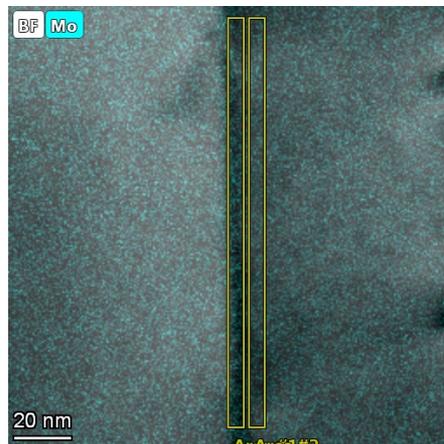
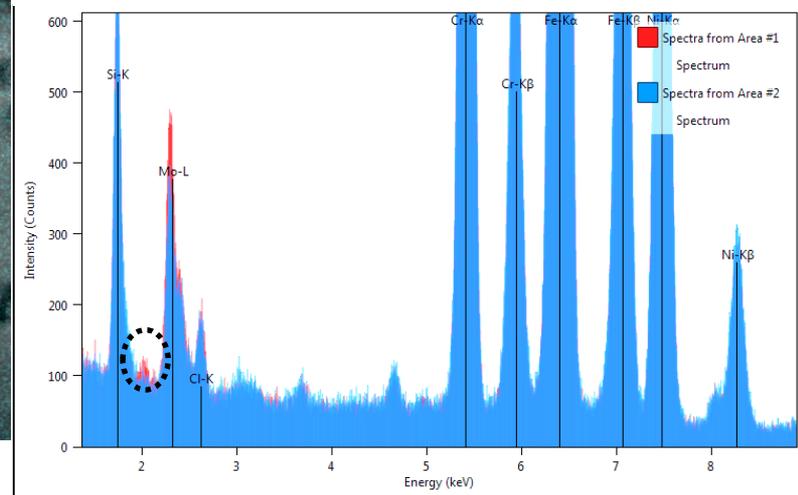
Non-Irradiated 316L SS: GB Segregation

“Lower” magnification:
Fe+Mo maps

- Detectable intergranular Mo segregation in as-received condition
- Confined to grain boundaries

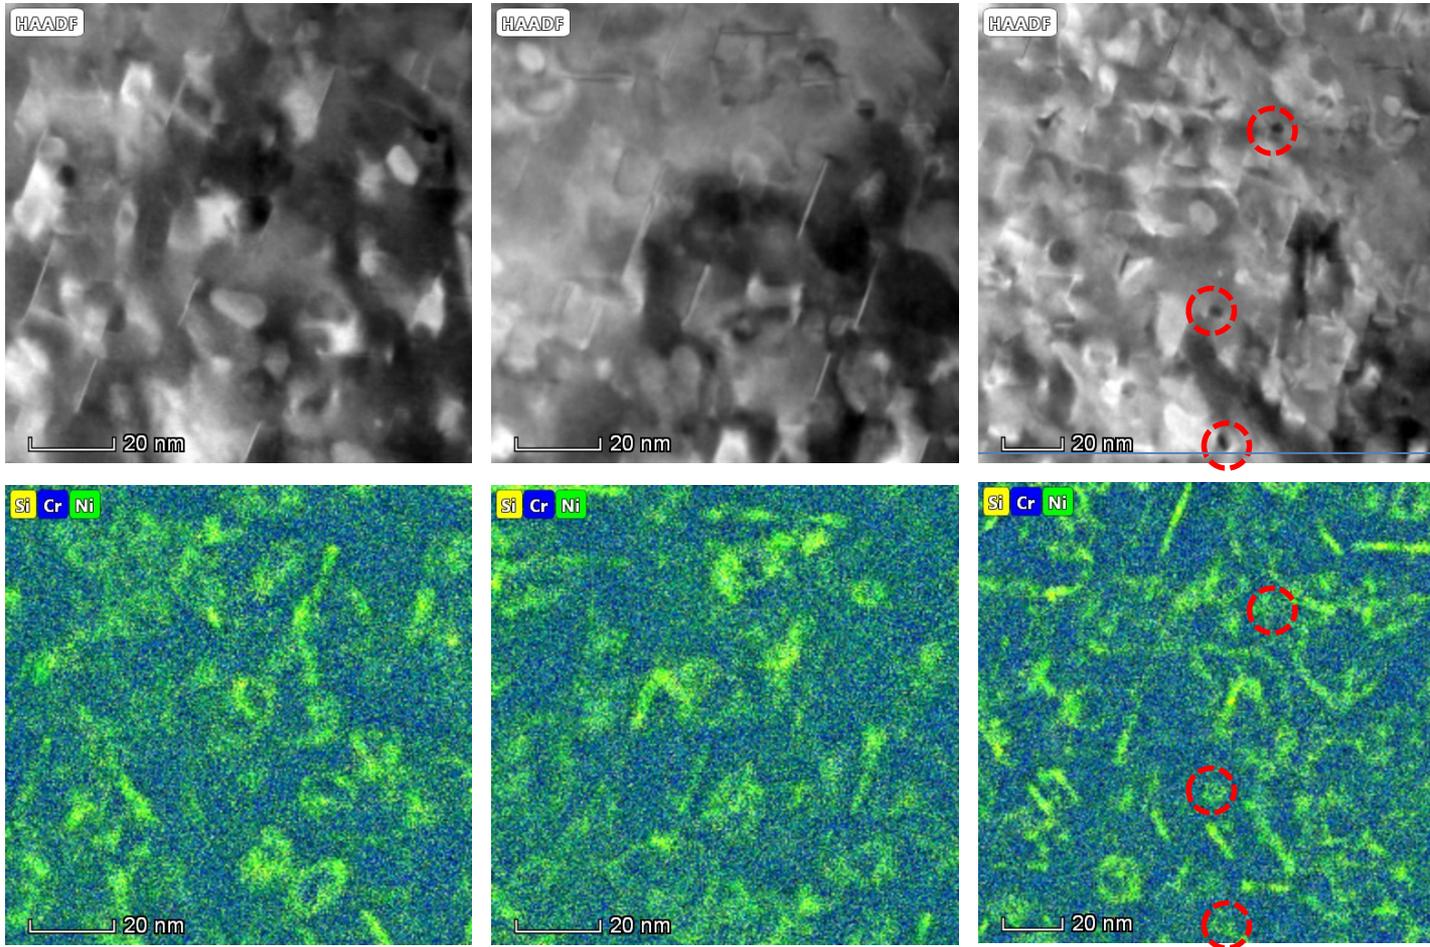
Proton-Irradiated 316L SS: 5 dpa at 350°C

- Clear Ni and Si segregation to loops, nano-scale cavities and pre-existing dislocations (Note ability to detect “out of contrast” dislocations/loops)

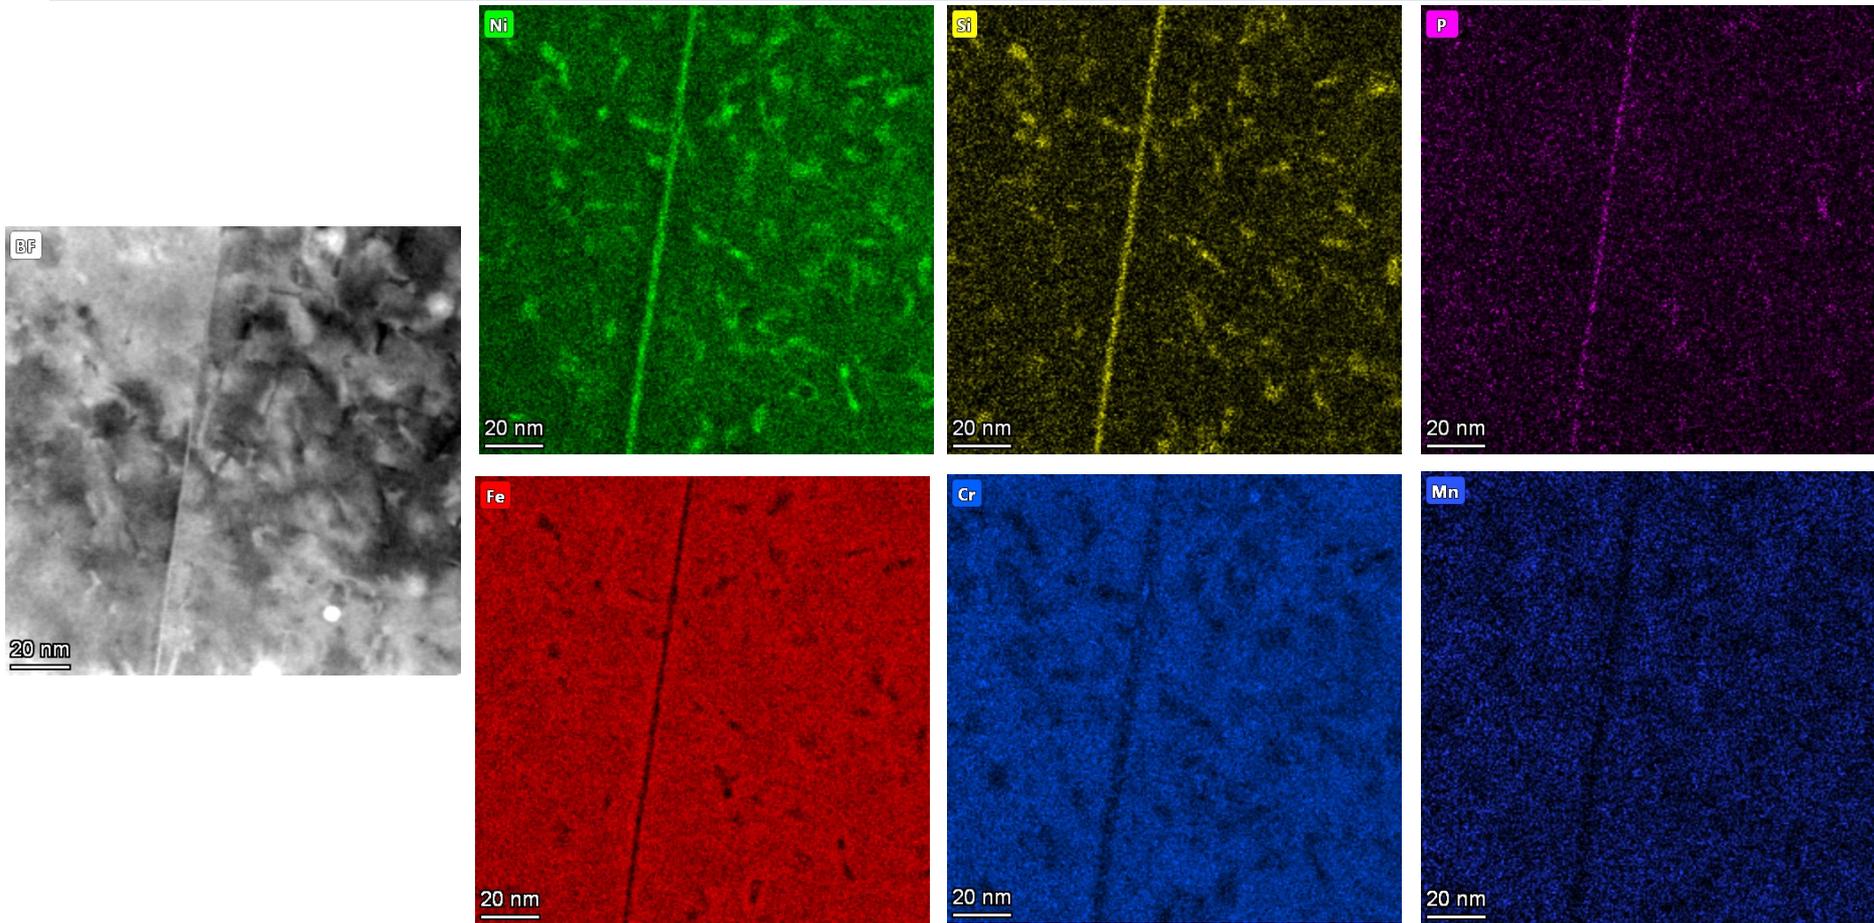
Proton-Irradiated 316L SS: 5 dpa at 350°C

- Proton-irradiation-induced segregation to irradiation-induced defects (loops/nano-scale cavities), pre-existing dislocations and grain boundaries

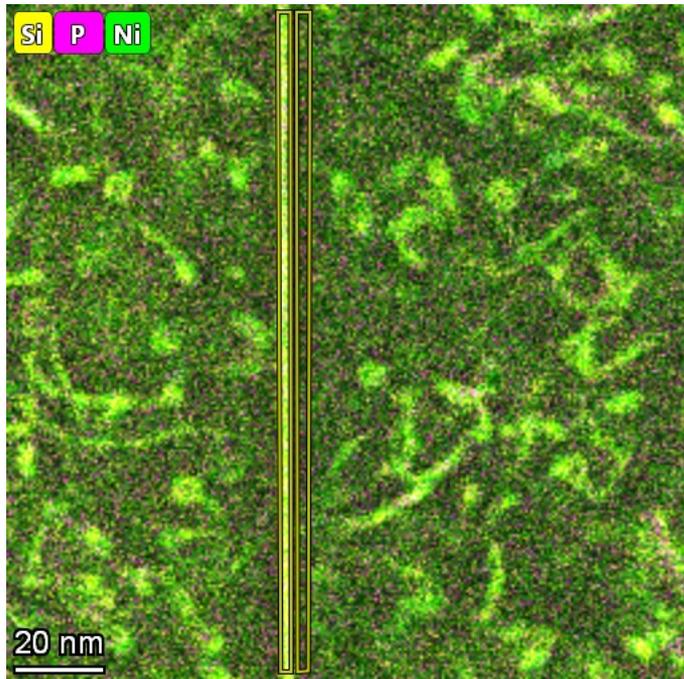
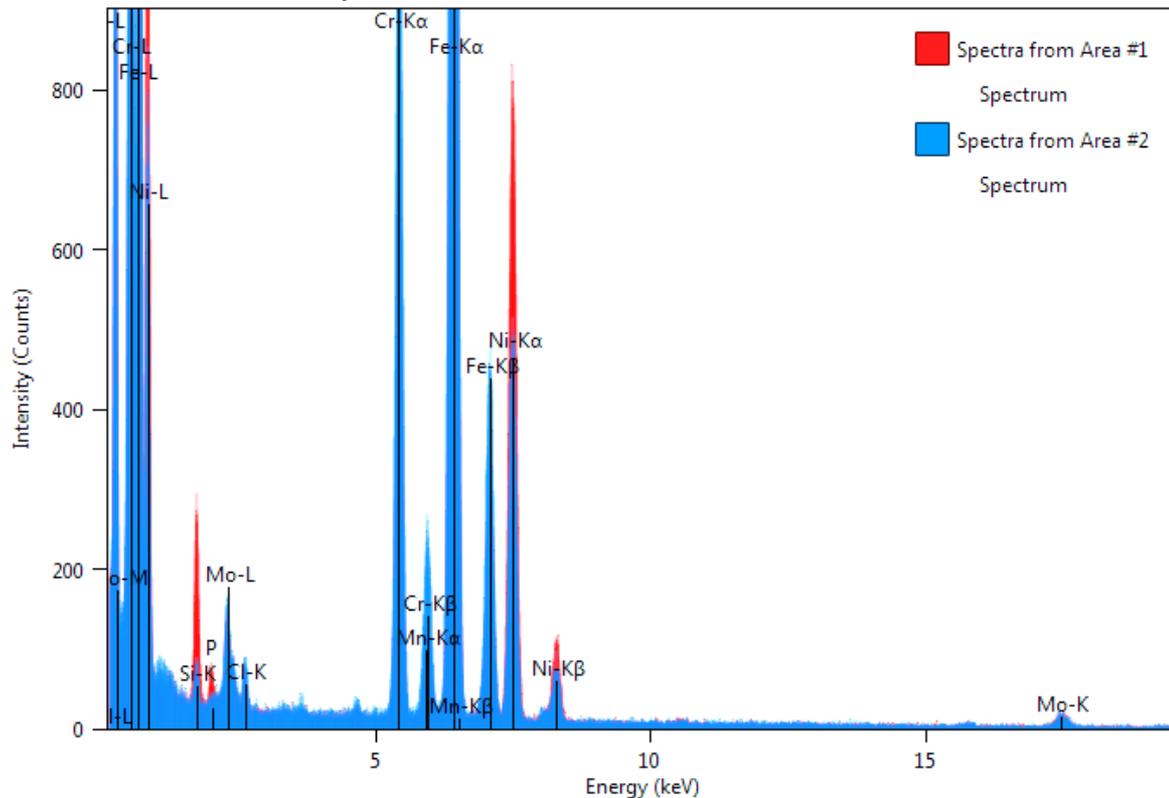
“Sum” EDX spectra extracted from SI datacube

- Extensive defect formation: Frank loops, nano-scale cavities
- Extensive RIS: Grain boundaries, pre-existing dislocations, irradiation-induced defects
- **Intergranular RIS: Si, Ni and P (No Mo)**

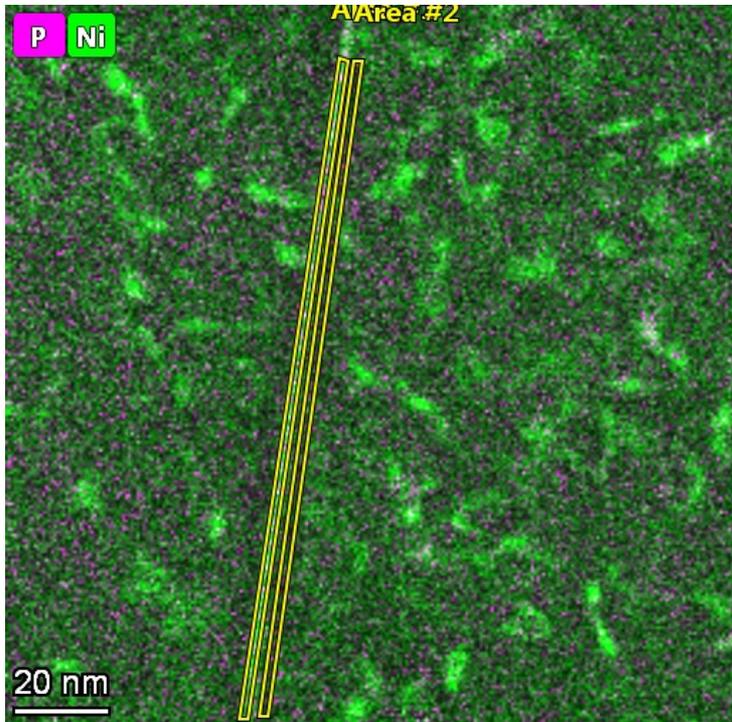
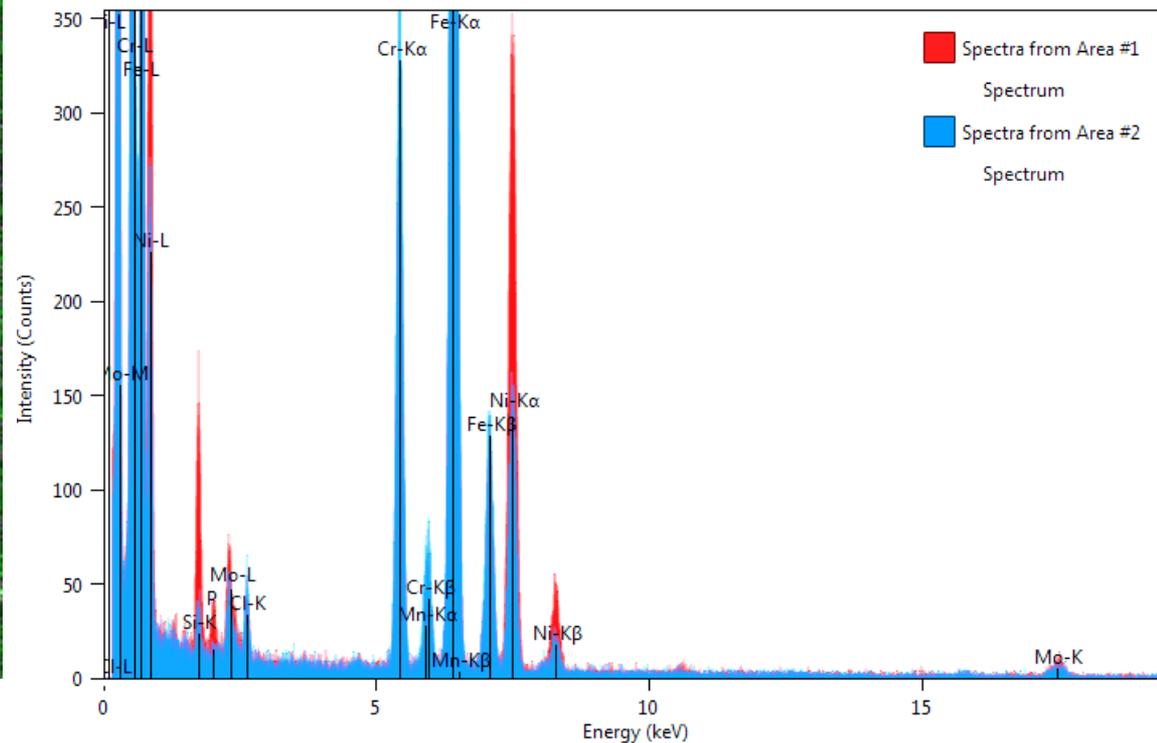
“Sum” EDX spectra extracted from SI datacube

- STEM-EDX SI dataset analysis: Significant enrichments of Si, P and Ni at grain boundaries
- Mo segregation similar to non-irradiated

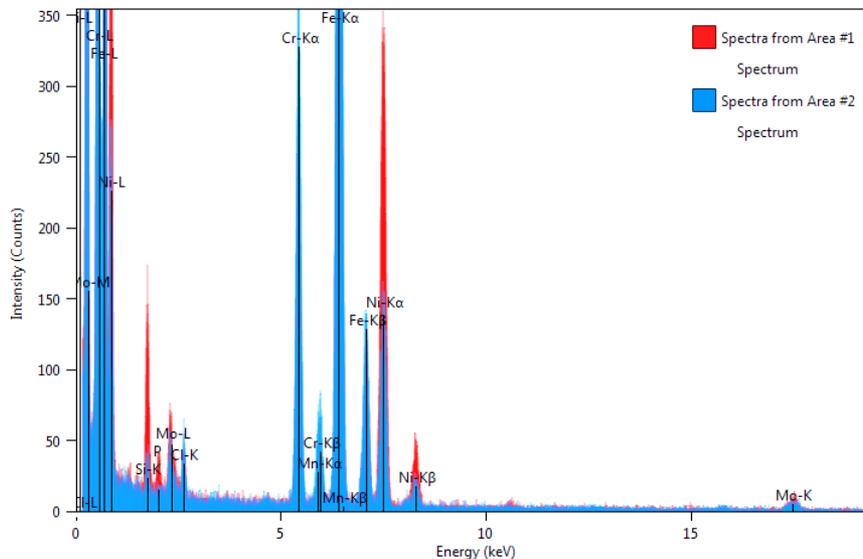
Proton-Irradiated 316L SS: Post-Test Analysis

- Pronounced intergranular Si and Ni (and P) segregation
- Segregation of Si and Ni to nano-scale irradiation-induced cavities, loops, and pre-existing dislocations
- Elevated Mo levels at boundary (similar to non-irradiated)

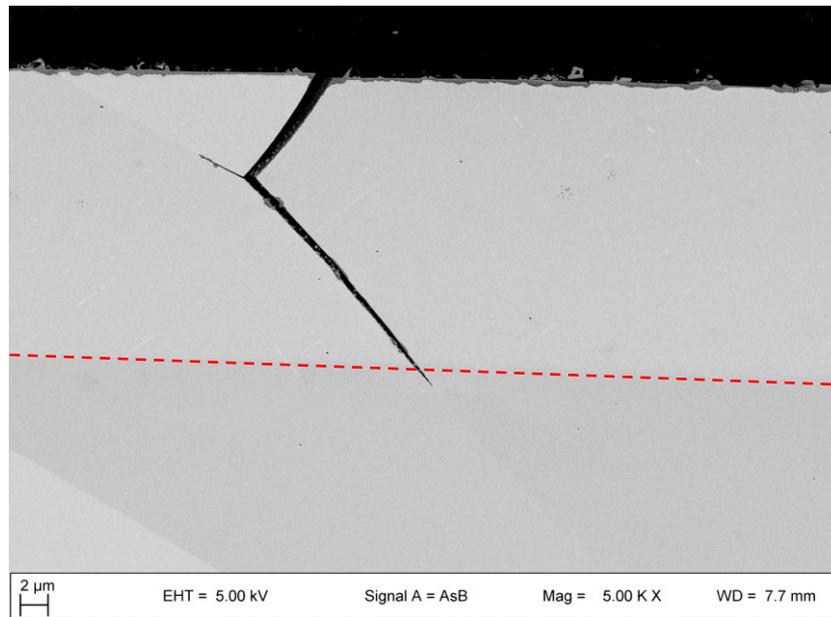
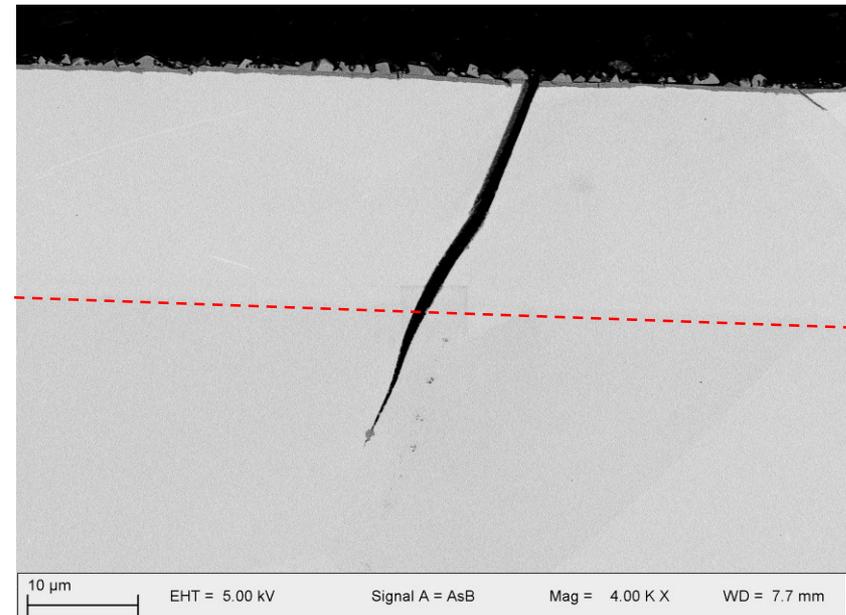
BSE Imaging: IASCC 4 pt Bend Specimens

- Discernable BSE contrast difference between the proton-irradiated “layer” and the non-irradiated “base”

- BSE image contrast delineation of proton-irradiated region
- Ability to detect oxide variation/Ni enrichments in the vicinity of the SCC oxide-metal interface

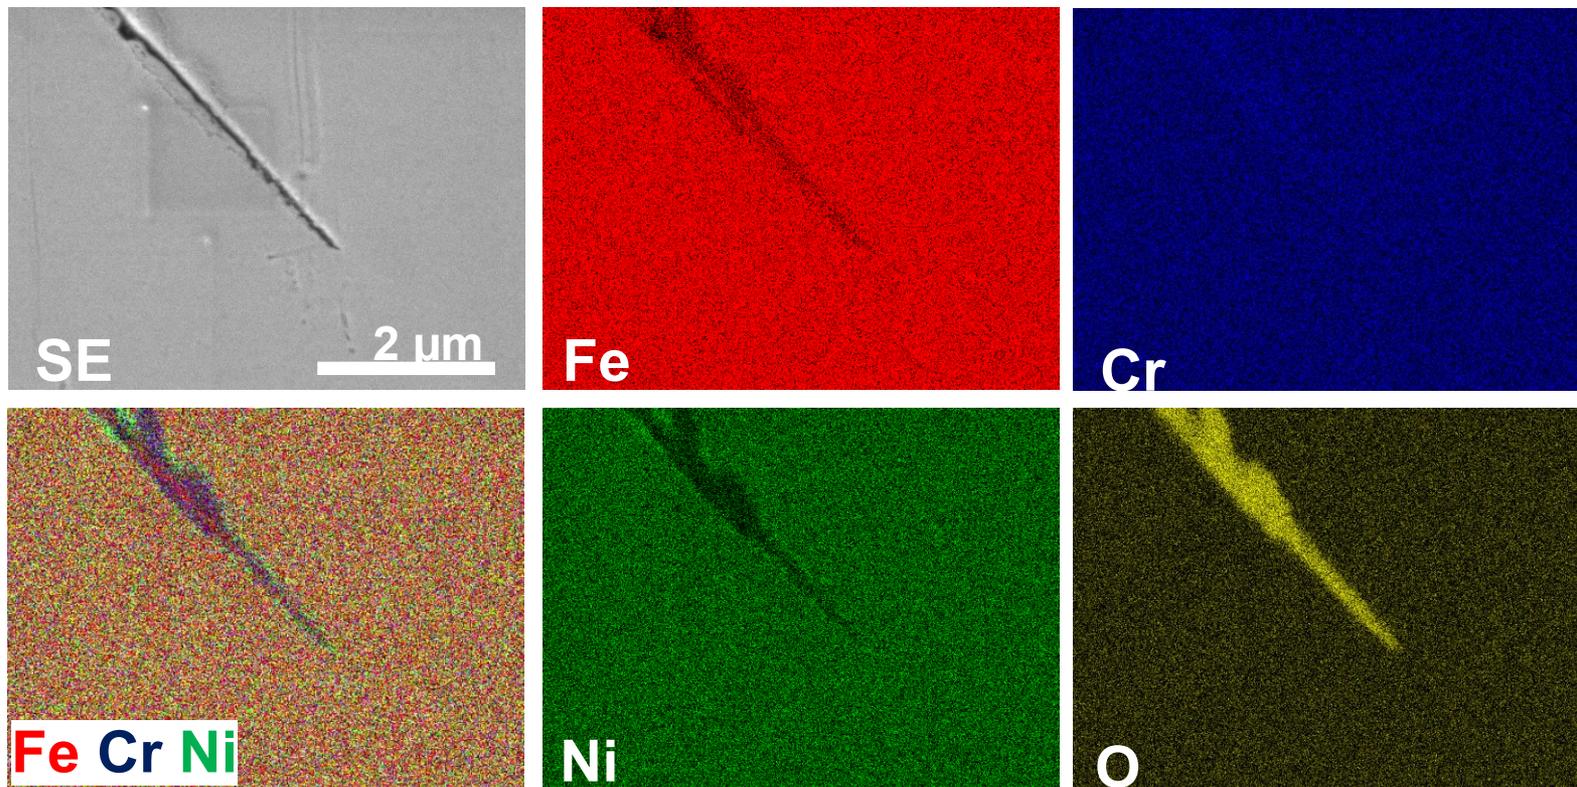
Proton-Irradiated 316L SS: Post-Test Analysis

5 kV FEGSEM-EDX Spectrum Imaging Analysis (~70 nm depth resolution)

- Oxide present within crack; Ni enrichment in vicinity of oxide/metal interface

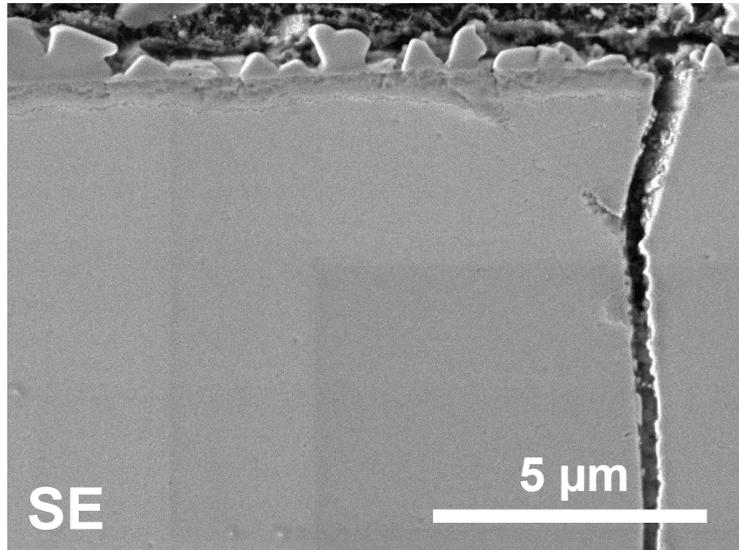
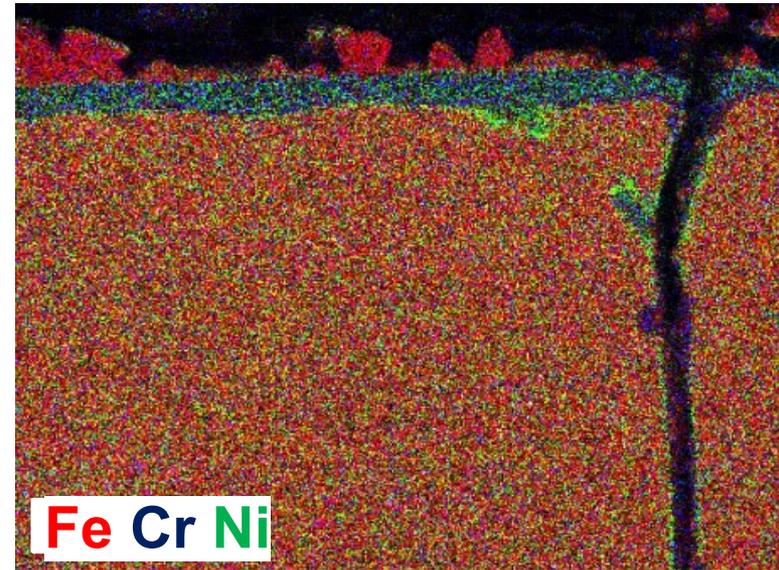
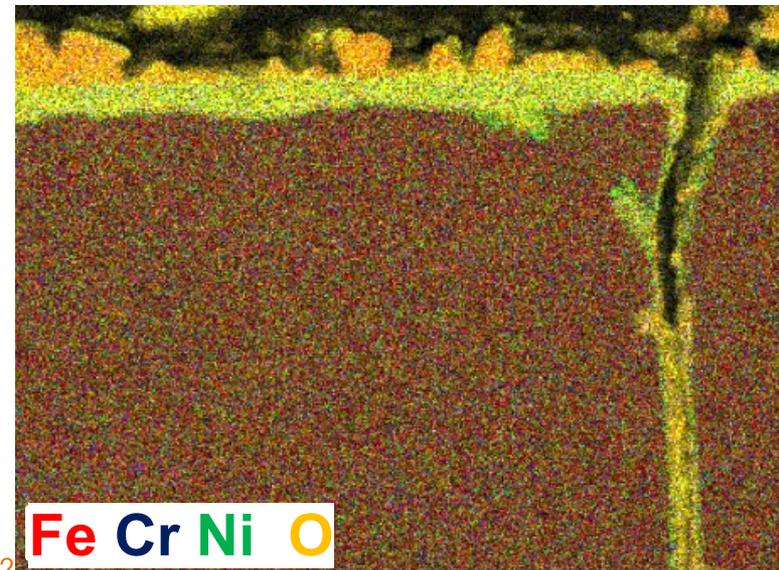
10 kV analyses (X-Max 150 SDD)

- Oxide present within crack;
Ni enrichment in vicinity of
oxide/metal interface

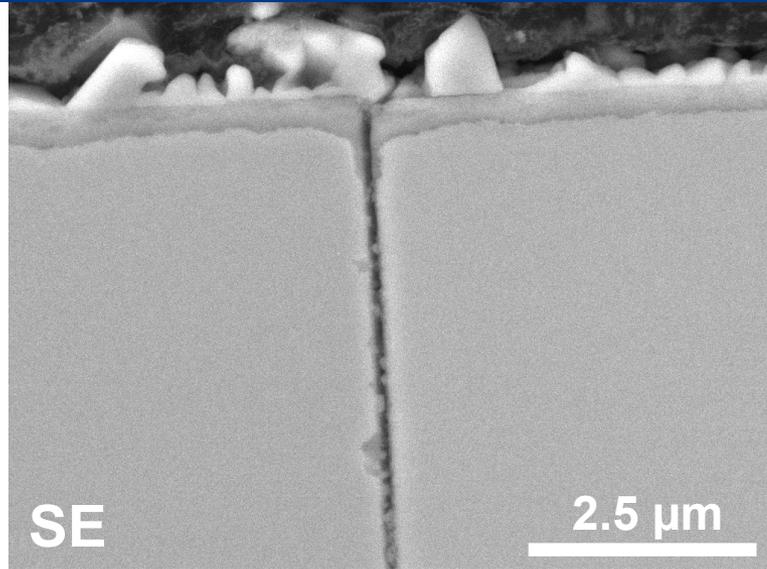
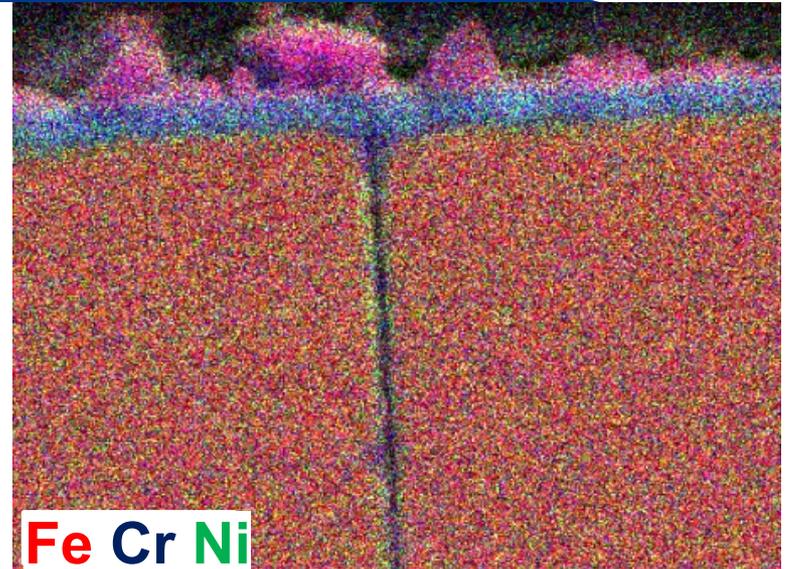
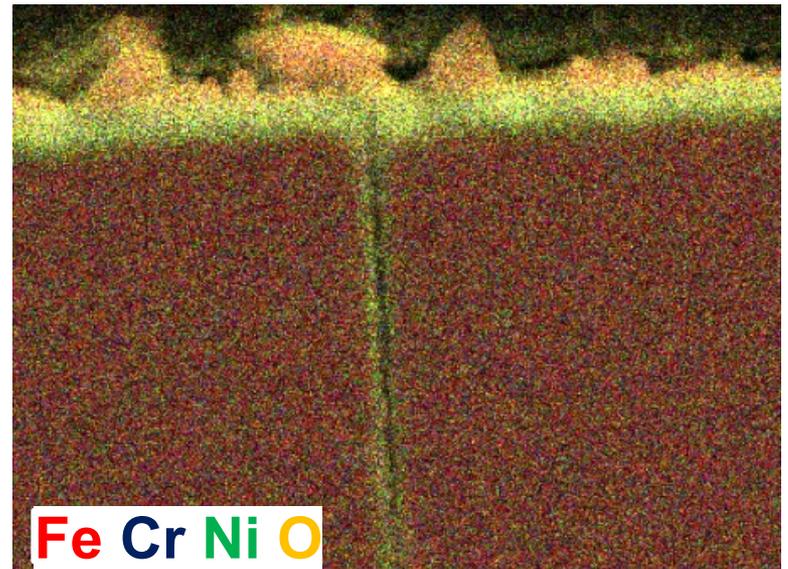
10 kV analyses (X-Max 150 SDD)

- BSE Images: Oxide present on crack walls
- Qualitative oxide EDX SI analysis: extracted elemental maps

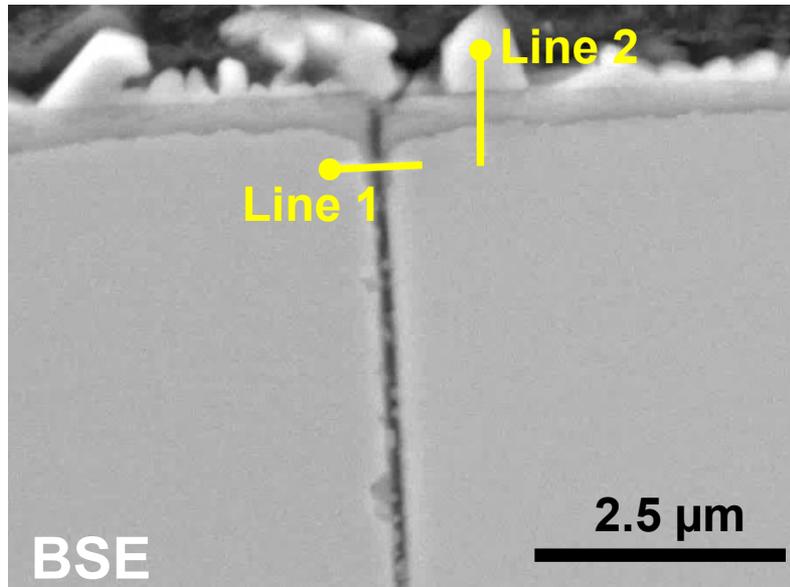
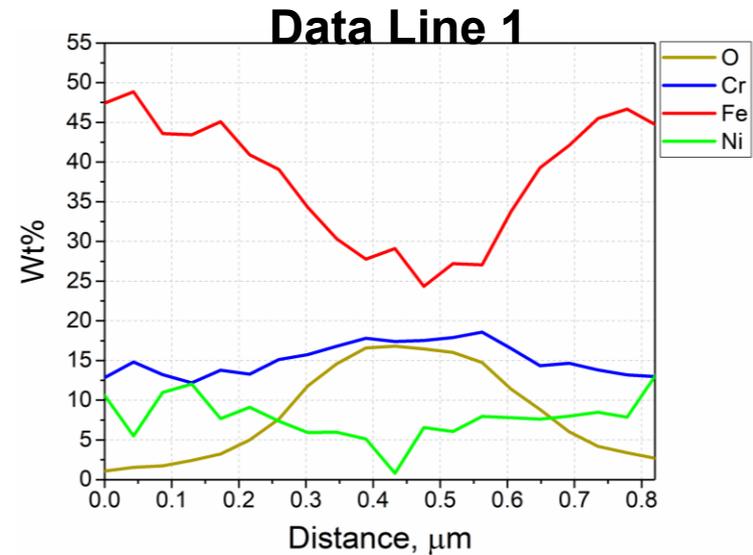
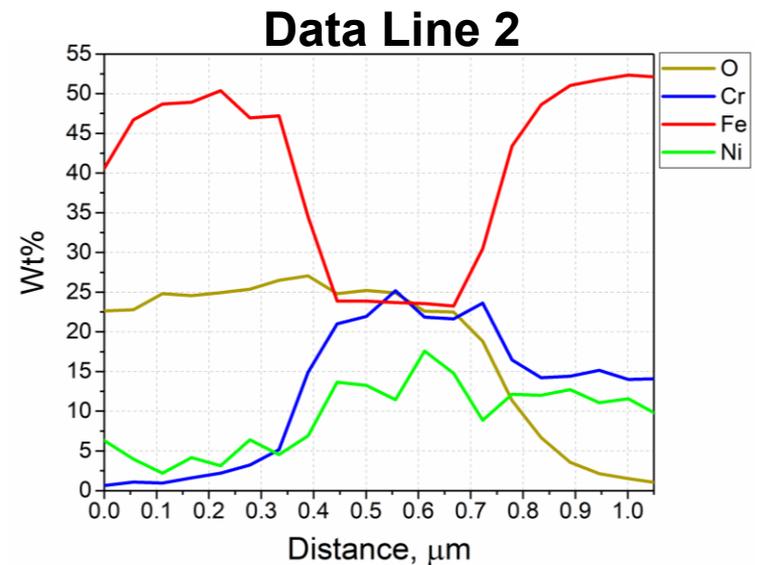
10 kV analyses (X-Max 150 SDD)

- BSE Image: Oxide present on crack walls
- Semi-quantitative profiles

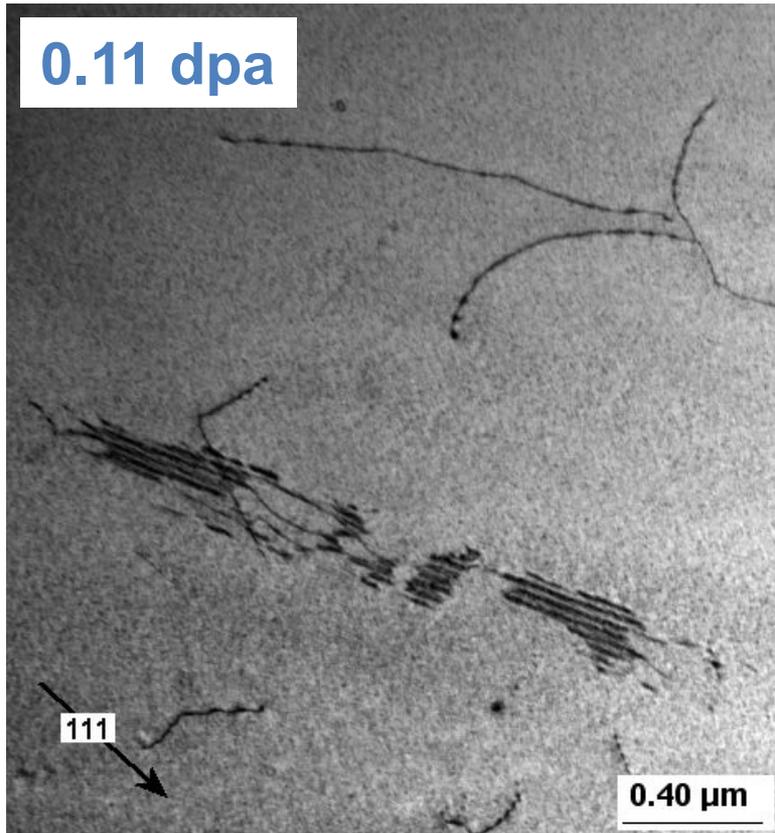
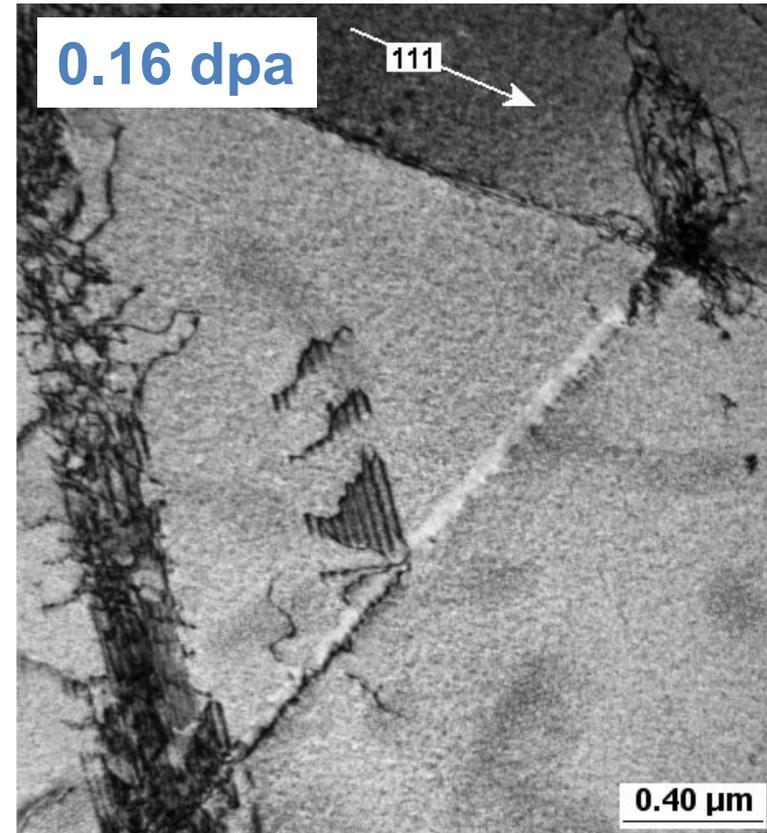
Solution-annealed 304L SS with relatively low amounts of irradiation, followed by low induced strain captures clear-band formation well; localized deformation is important for IASCC.

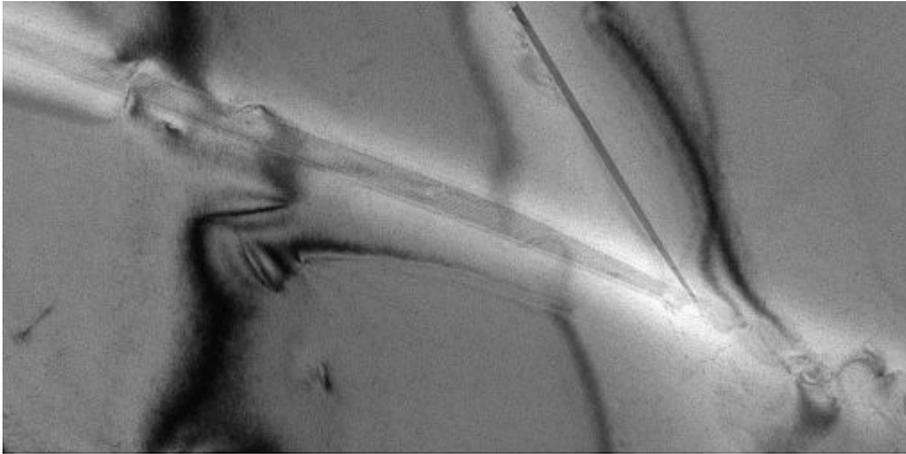
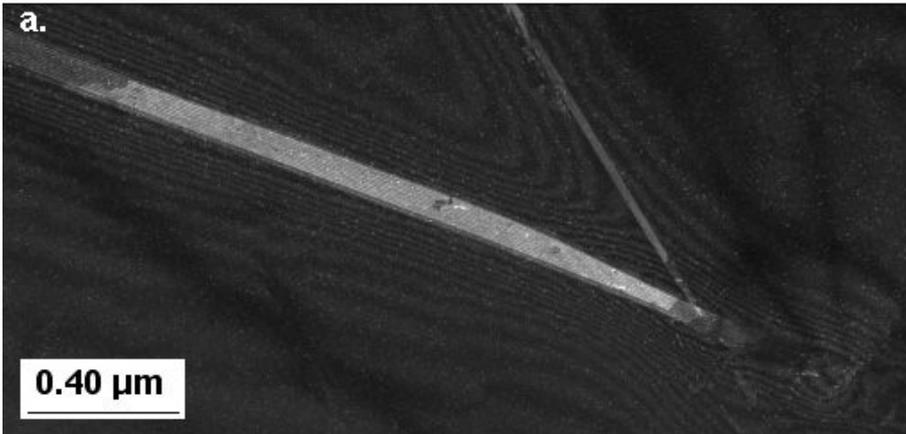
All of the specimens showed stacking faults to some degree as well, generally restricted to the channels.

Upon accumulation of several stacking faults, satellite spots have distinct d-spacing which correspond most closely to that of HCP-epsilon martensite.

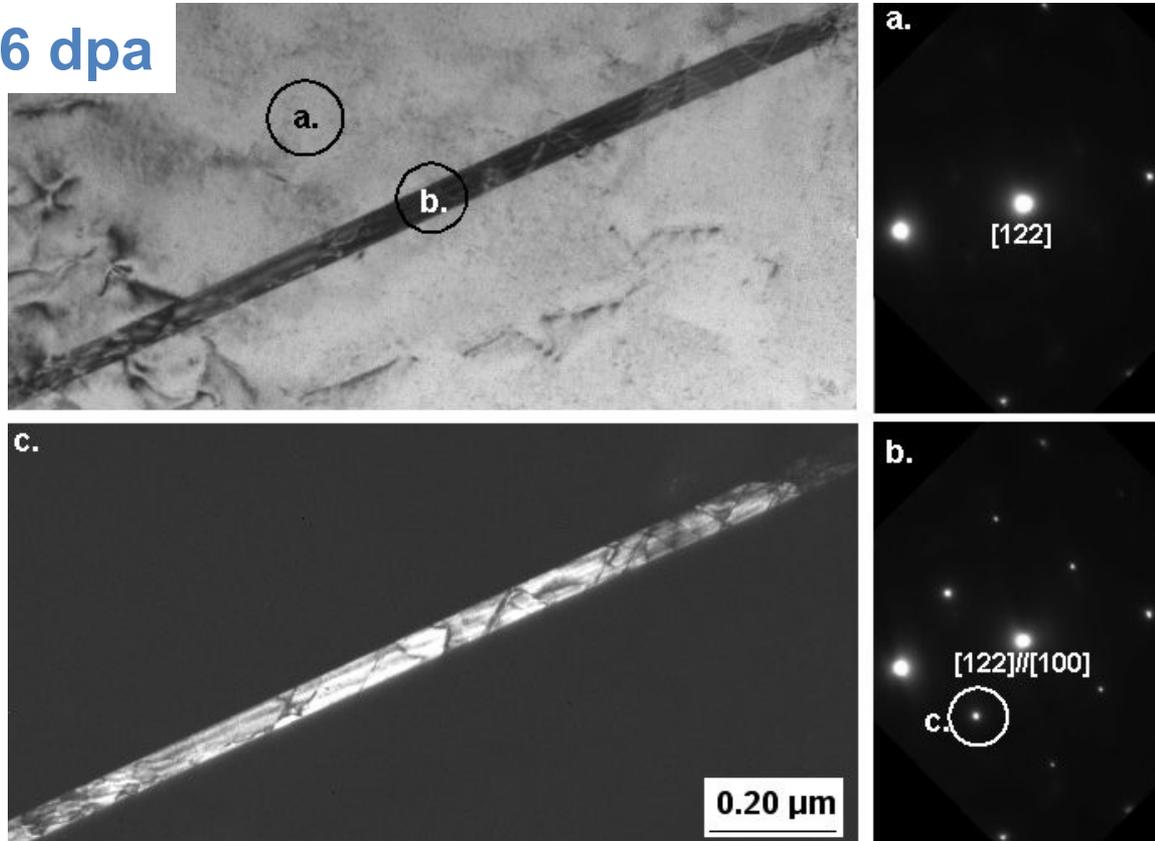
Further accumulation of overlapping stacking faults in a band introduced strong reflections corresponding to austenite phase of different orientation, indicating the formation of a twin.

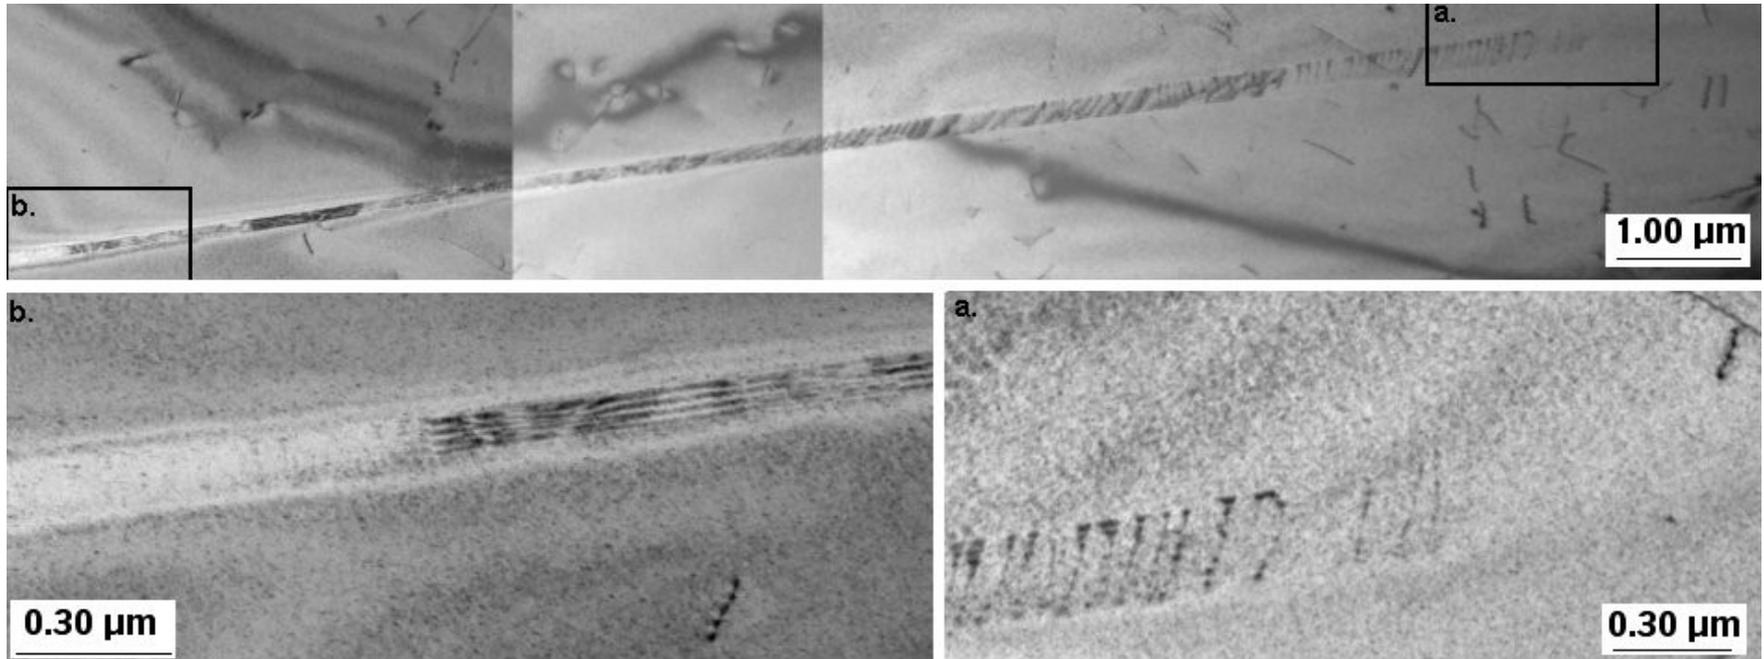
Channel in 0.11 dpa material demonstrates several stages of evolution process:

- head of channel marked by several dislocations (a.)
- followed by gradual separation of partial dislocations, overlapped in some regions → strong contrasts indicating different planar stacking
- left behind a band with reduced defect density (b.).
