IRRADIATION EFFECTS ON MICROSTRUCTURAL EVOLUTION

Grace Burke, University of Manchester

Wade Karlsen, VTT

Microstructural Characterization of Proton-Irradiated Type 316L SS

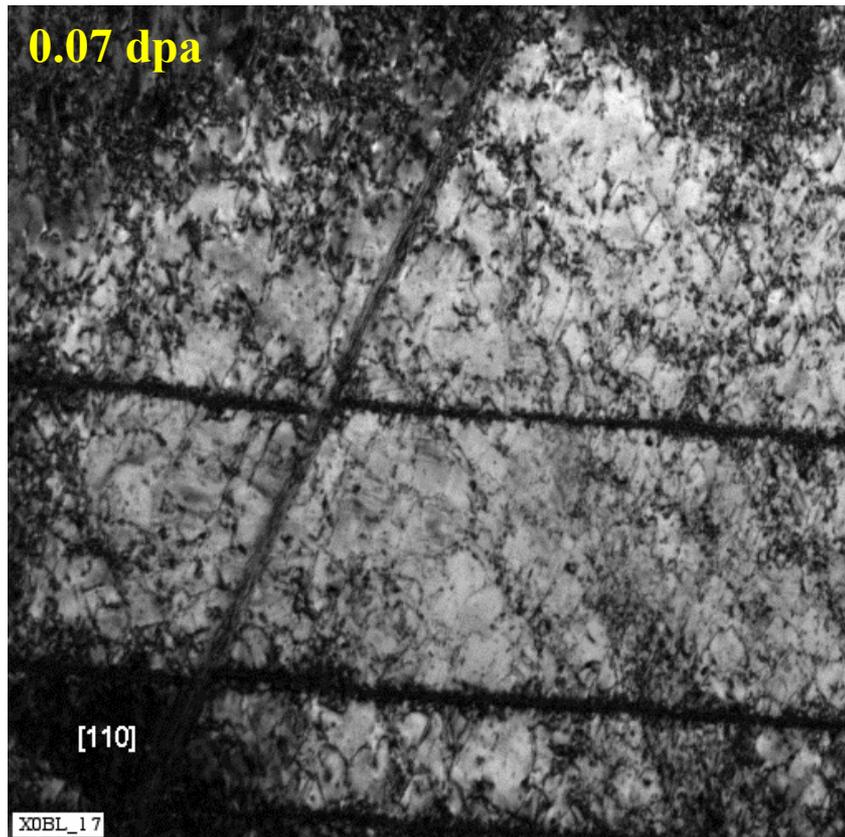
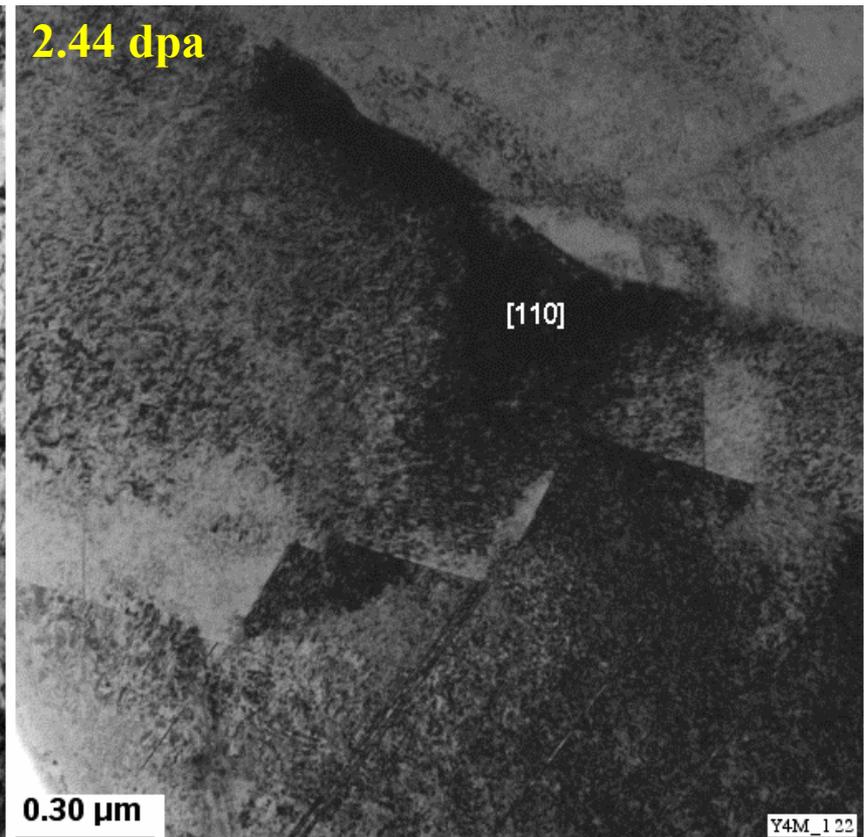
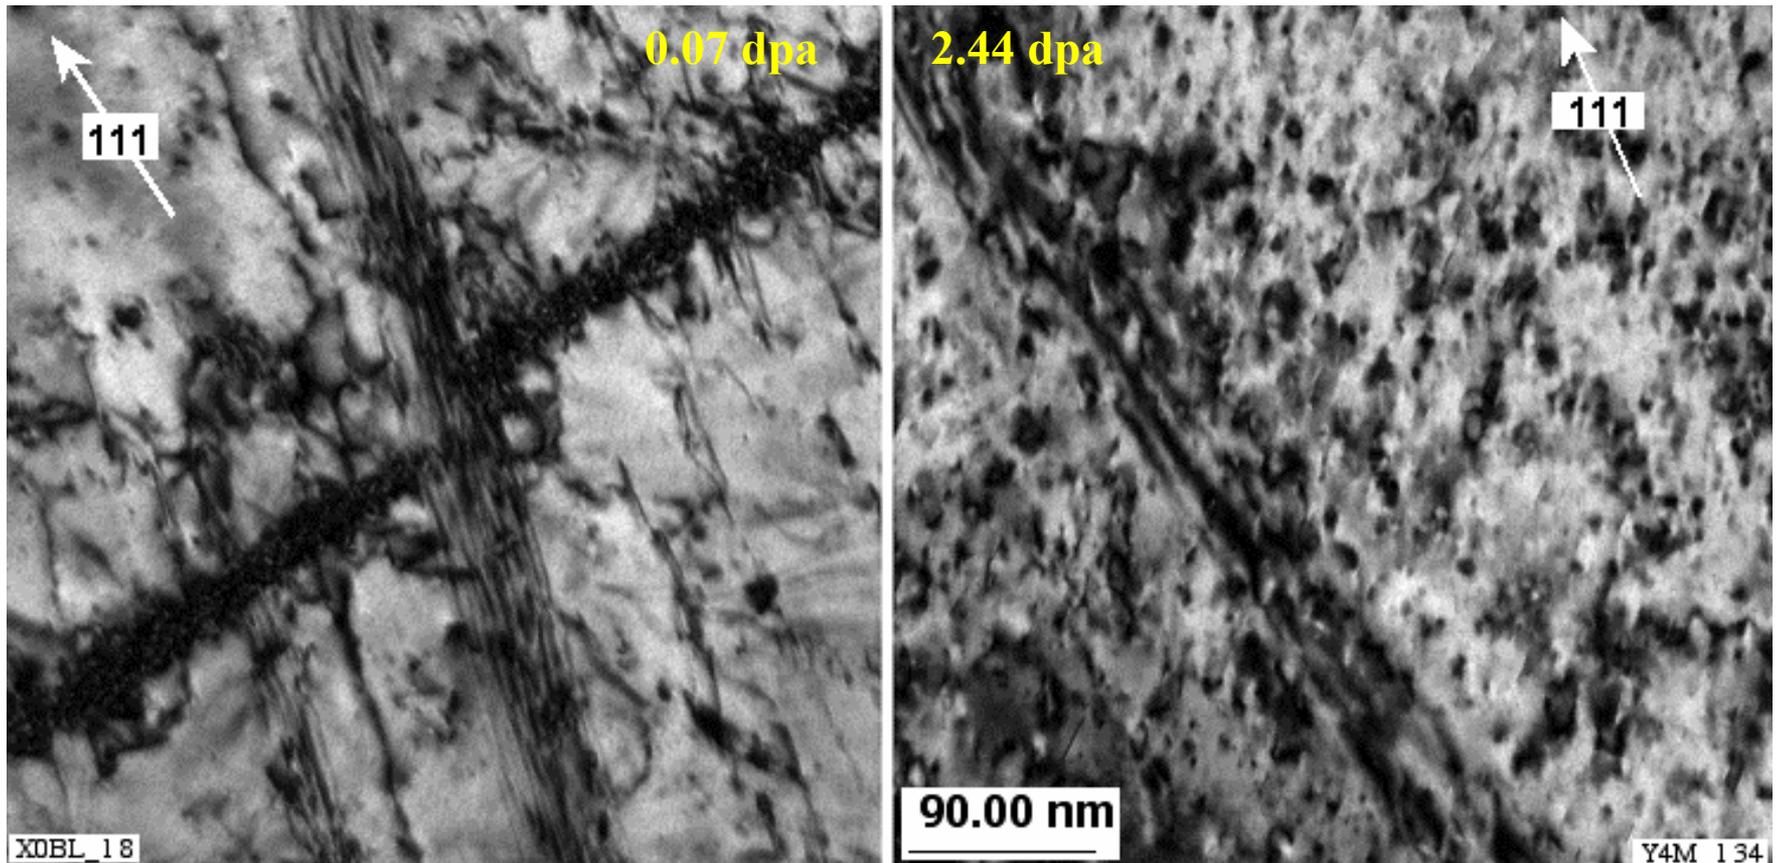
In cold-worked 304 SS material, radiation annihilates linear dislocations and replaces with dislocation loops.

Irradiation effects on increasing dpa

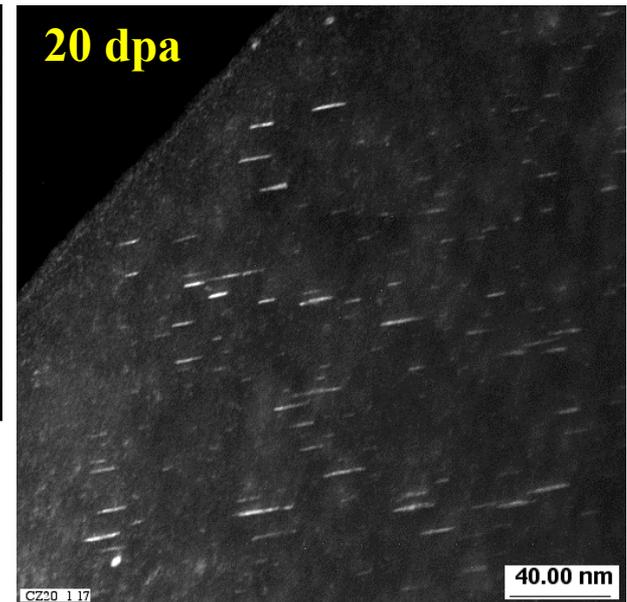
Faulted dislocation loop population is typically viewed and quantified by employing rel-rod dark-field method.

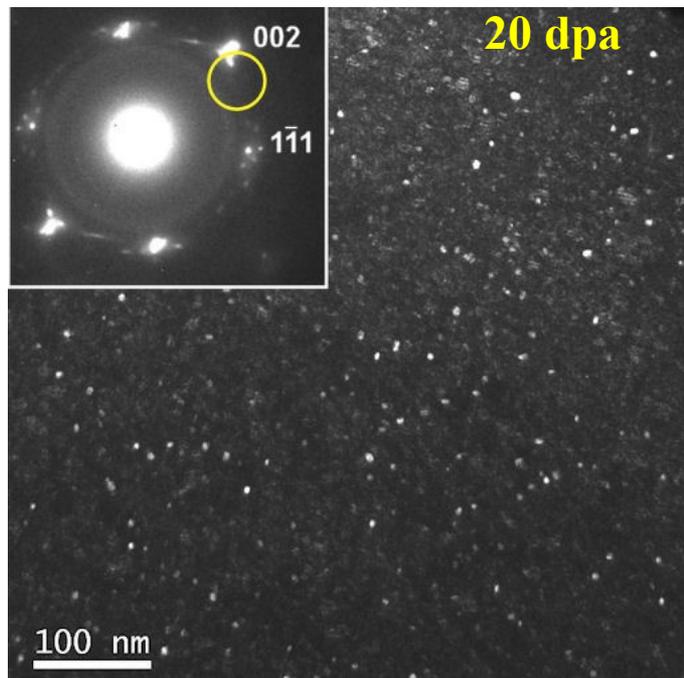
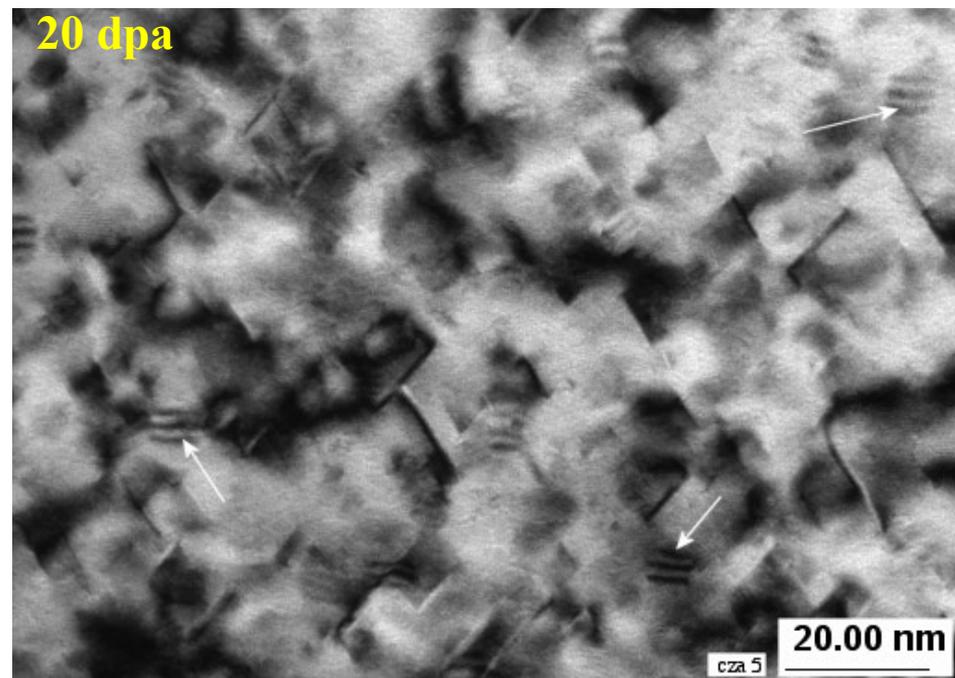
At very high dpa's, precipitation of a Ni&Si-rich phase emerges in the matrix (gamma prime).

- Coherence with matrix is evident from SAD pattern, and also by Moiré contrasts in BF image, but DF-imaging is still possible.

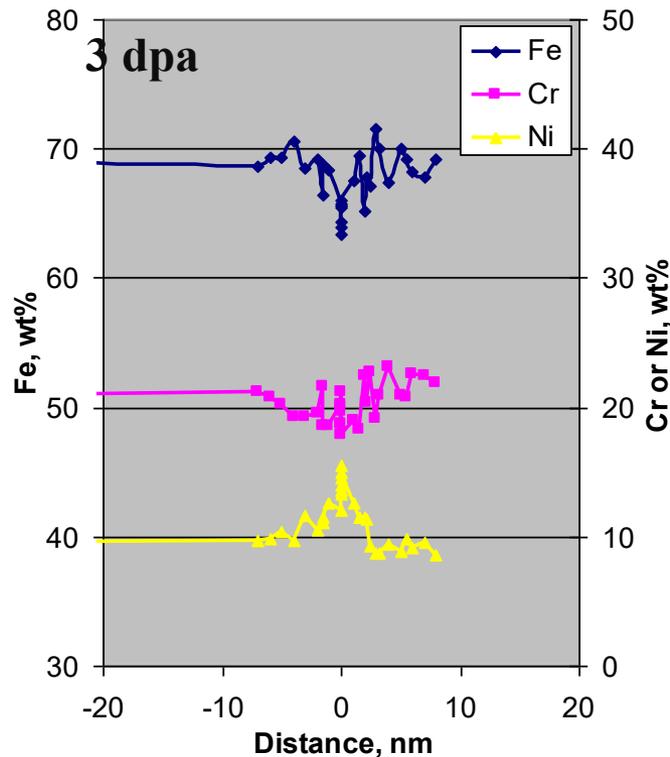
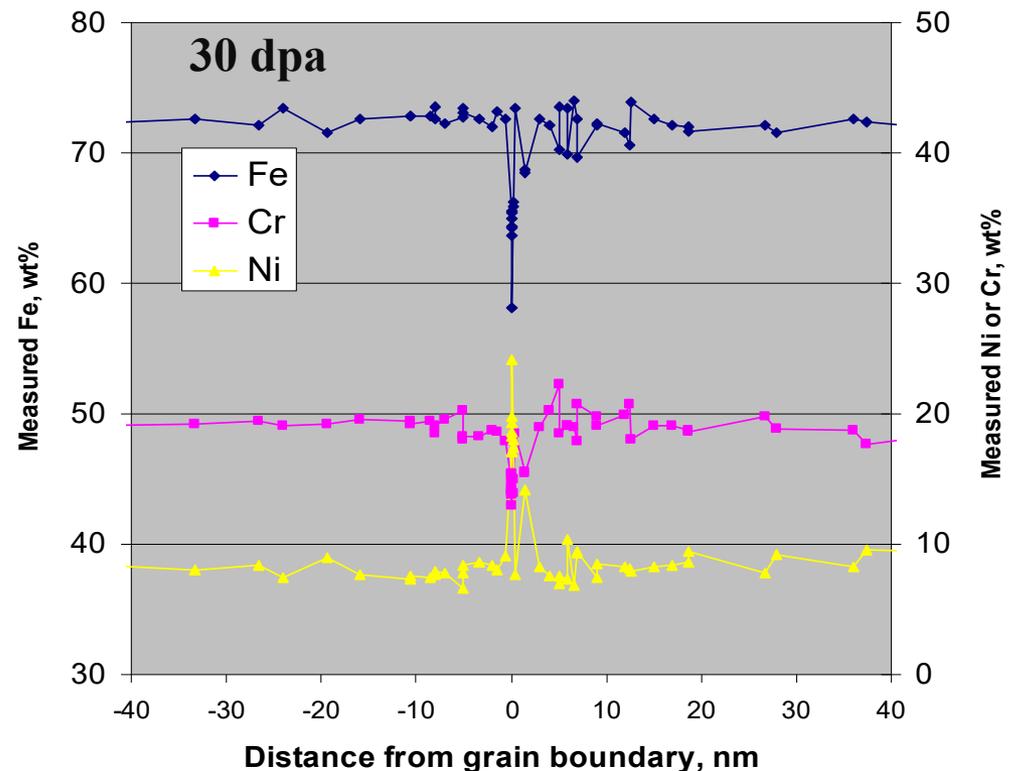
Grain boundaries experience increasing radiation-induced segregation with increased dpa.

- Significant Ni- and Si-enrichments; **Fe** and Cr-depletion

- RIS at GBs and as precipitates in 30 dpa SA 304L.

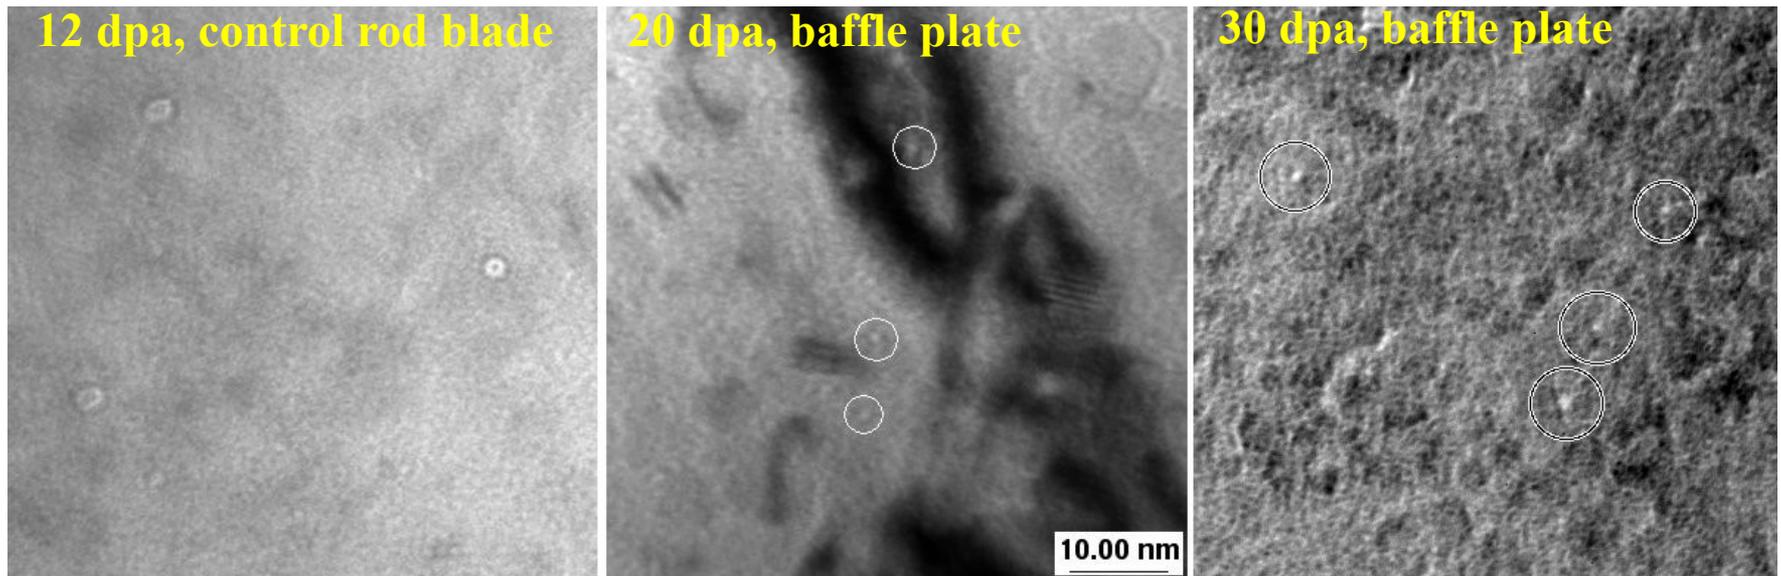
At very high dpa's, cavities also emerge in the matrix.

- Viewed at high magnification in slightly under-focus condition.
- Size of cavities may be more thermally-dependent than dpa-dependent, as different components (locations in reactor) exhibit different cavity populations.

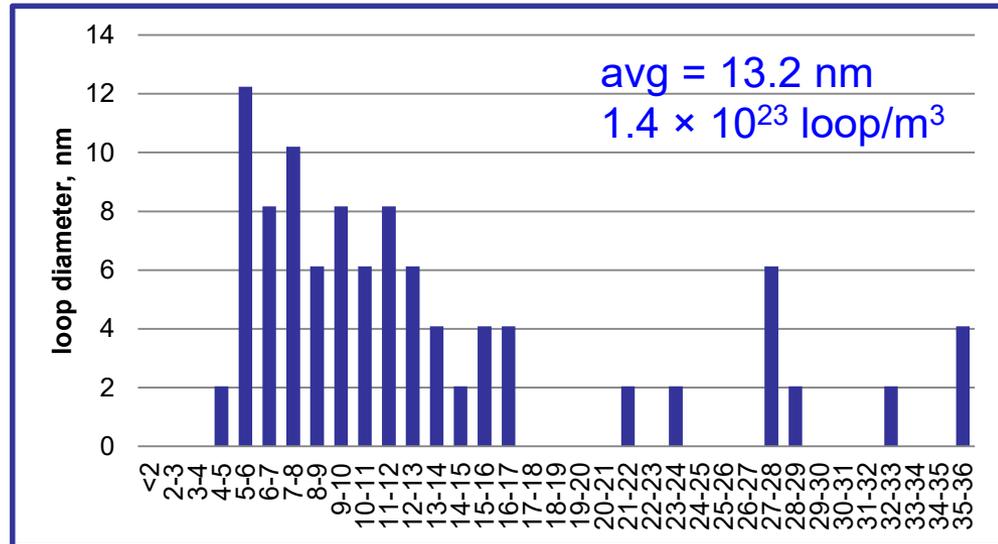
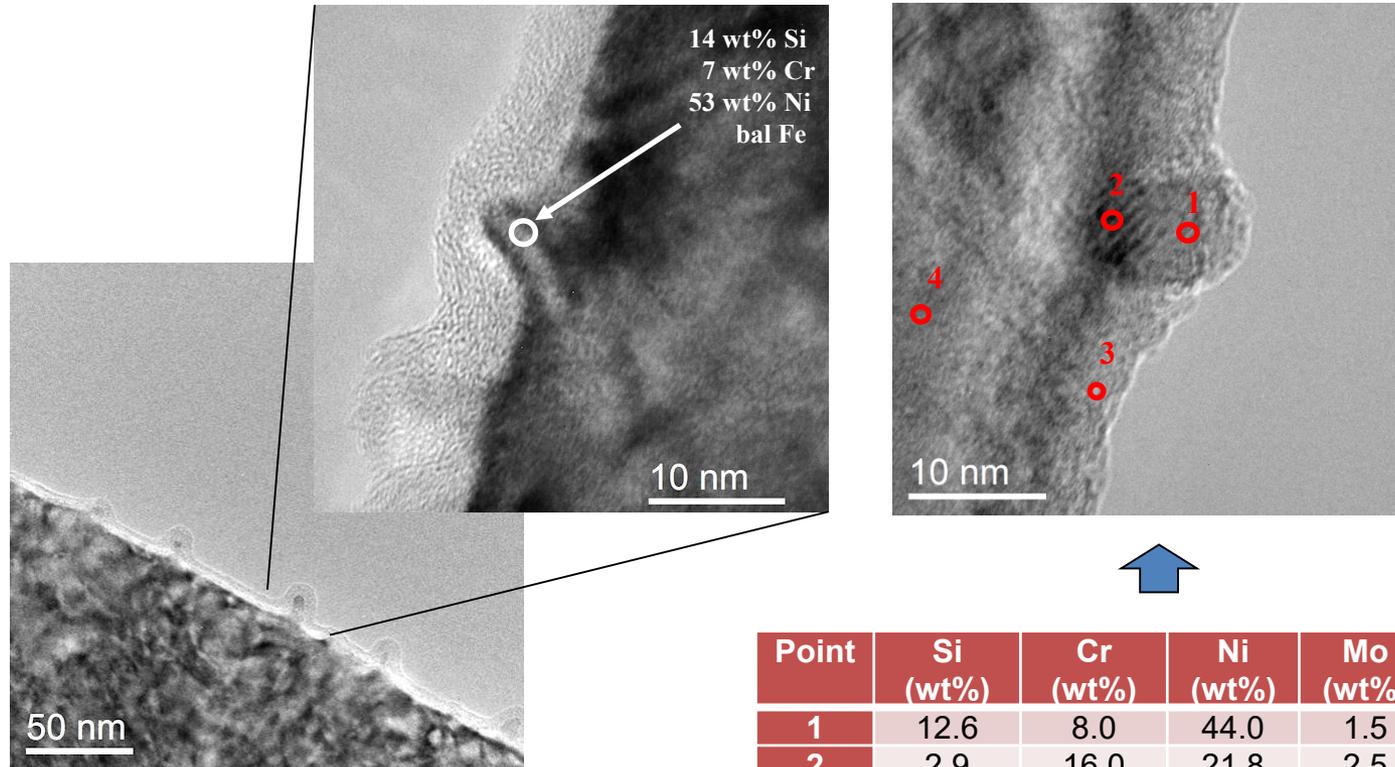
□ Analysis of radiation-induced segregation

Point	Si (wt%)	Cr (wt%)	Ni (wt%)	Mo (wt%)	Fe
1	12.6	8.0	44.0	1.5	bal
2	2.9	16.0	21.8	2.5	bal
3	0.7	24.9	8.3	4.8	bal
4	0.8	21.0	10.4	3.2	bal

Note that Fe is depleted when Cr is depleted

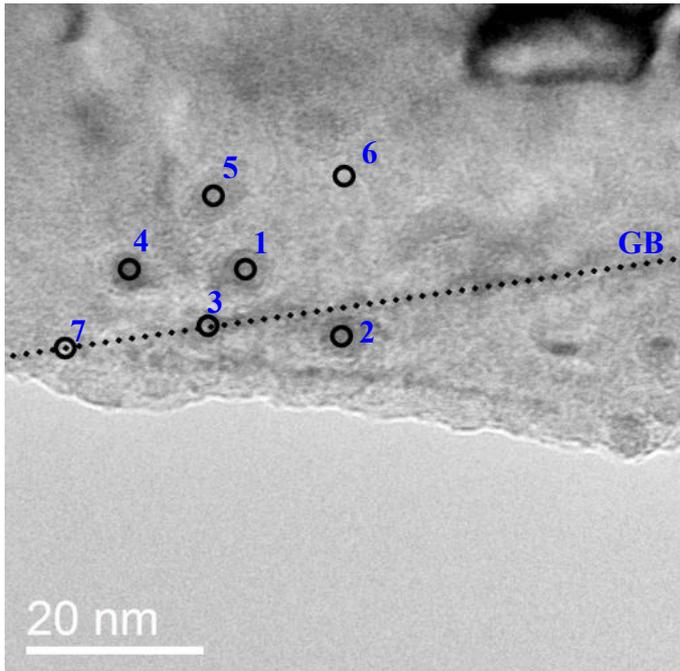
□ Analysis of radiation-induced segregation

Grain boundary composition

Point analyses in vicinity of GB

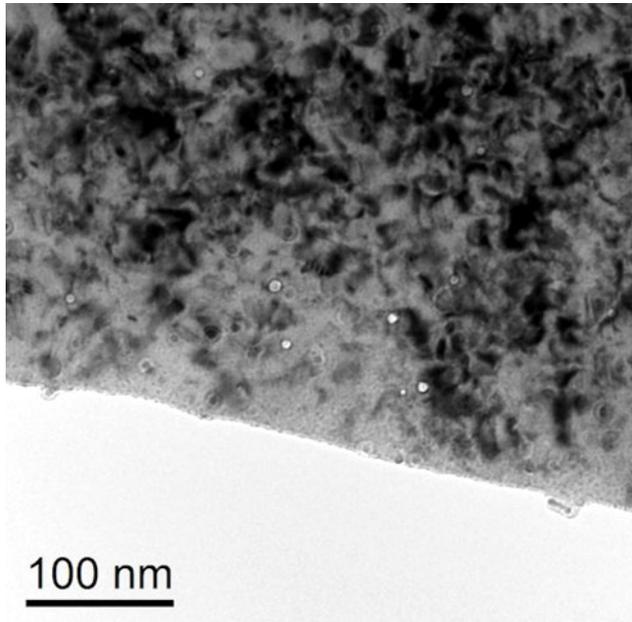
□ Analysis of cavities and cavity-RIS

Point	Si (wt%)	Cr (wt%)	Ni (wt%)	Mo (wt%)	Fe
8	6.5	12.1	31.2	0.7	bal
9	1.2	18.3	12.6	3.0	bal
10	1.6	16.4	15.7	3.0	bal
11	2.6	16.7	18.6	3.1	bal
12	2.0	17.6	13.6	1.8	bal
13	1.1	18.2	12.9	2.0	bal
19	1.2	19.2	13.0	1.8	bal
20	1.3	19.0	13.7	2.5	bal
21	0.5	20.8	8.5	1.6	bal

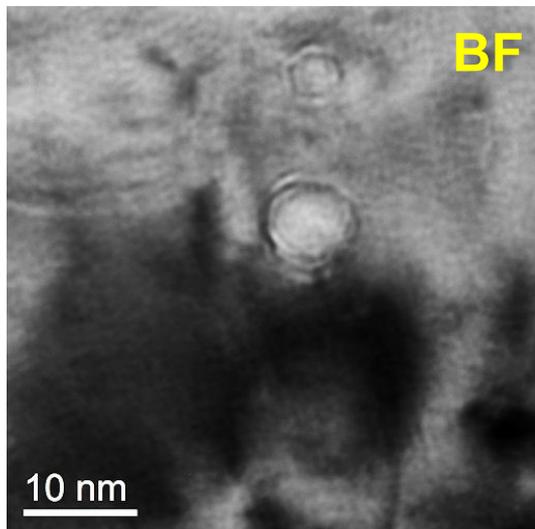
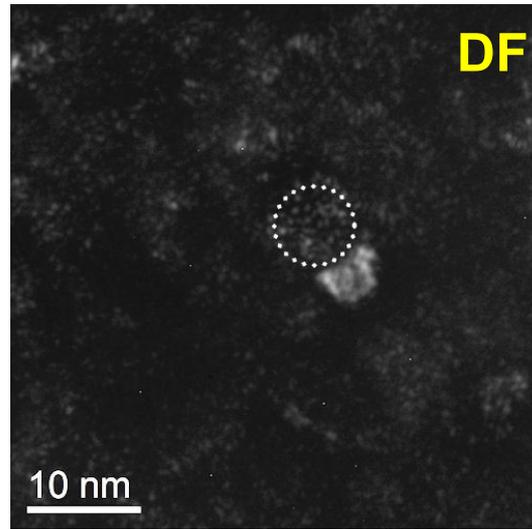
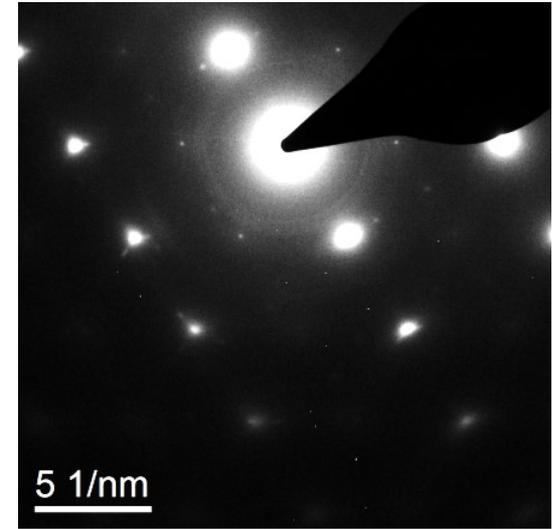
- Bright field/dark field image pair of one void region reveals a precipitate associated with the void.
- SAD of the examined region showed the presence of precipitates with a lattice relation to the matrix (small spots).
- Voids shrank upon EDS analysis.

- Summary of observations from 17dpa baffle bolt slice
 - Frank loops with a concentration of 1.4×10^{23} loop/m³ were found. Average loop size was 13.2 nm.
 - GBs showed clear RIS, as well as the presence of precipitates rich in Si and Ni.
 - One ppt phase was identified as γ' (Ni₃Si); had a lattice relation with fcc matrix.
 - Voids/bubbles ~5-10 nm were present in the microstructure.
 - Void walls also showed clear RIS. However, there were indications that the RIS was not constant at the void surfaces.
 - Voids and precipitates were found to often be associated with one another.
 - Voids shrank upon EDS analysis, which could indicate either gas diffusion out of them, or flux of interstitials to the void wall.

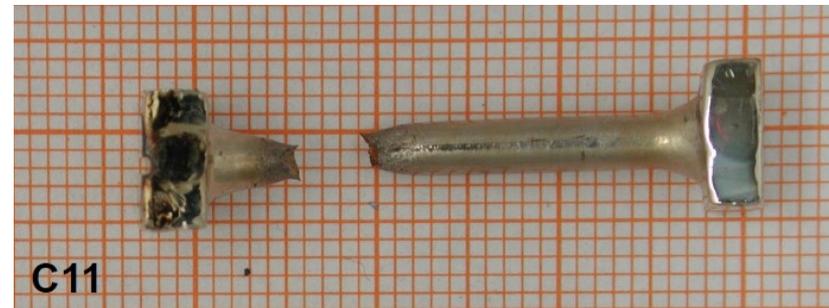
IASCC example study; fractures

TEM specimen	Test bar	Distance from fracture
C4_2	C4 (CL)	1.5 mm
C5_1	C5 (CL)	0.5 mm
C5_2	C5 (CL)	2.0 mm
C10_1	C10 (SSRT)	0.5 mm
C11_2	C11 (SSRT)	1.0 mm
C11_3	C11 (SSRT)	1.5 mm
C11_5	C11 (SSRT)	2.0 mm
C11_5	C11 (SSRT)	~ 15 mm

TEM specimen	Test bar	Distance from fracture	Deformation features
C4_2	C4 (CL)	1.5 mm	a few clear channels, a few small blooms of alpha martensite, but mostly no deformation
C5_1	C5 (CL)	0.5 mm	sparse population of twin-containing bands, a few small and large regions of alpha martensite
C5_2	C5 (CL)	2.0 mm	no deformation evident
C10_1	C10 (SSRT)	0.5 mm	one large region containing alpha martensite next to a region of closely-spaced stacking faults
C11_2	C11 (SSRT)	1.0 mm	heavy deformation in crisscrossing clear channels containing epsilon martensite and twins
C11_3	C11 (SSRT)	1.5 mm	significant deformation in crisscrossing clear channels containing some epsilon martensite
C11_5	C11 (SSRT)	2.0 mm	deformation mostly in crisscrossing clear channels, some containing epsilon patches
C11_5	C11 (SSRT)	~ 15 mm	no deformation evident

- ❑ SSRT test conducted in argon produced substantial deformation through cleared channels, even 2 mm from the fracture surface, but the bar fractured in ductile manner.
- ❑ SSRT and CL tests in PWR environment and CL test in argon resulted in very little deformation product, even as close as 0.5 mm from the fracture surface, but showed significant IG fracture.
- ❑ Alpha martensite stood out as an interesting feature found at the proximity of the IG fracture surfaces.
- ❑ The combination of martensite and hydrogen may be an important factor in the IG fractures observed in this material.
