TEM INVESTIGATION OF ION AND NEUTRON IRRADIATED AUSTENITIC STAINLESS STEEL

TASK 2.2: FLUX EFFECTS ON INTERNALS

M. Hernández-Mayoral, S. Guerra (CIEMAT)

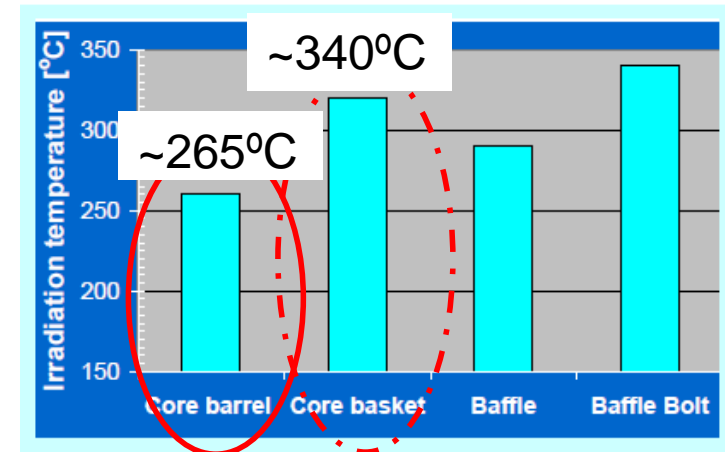
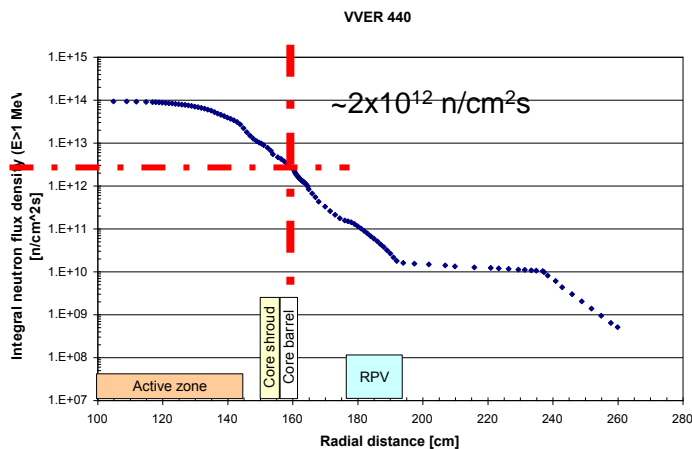
Section of WVER 440 internals and calculated integral neutron flux density in course of reactor core radial dimension.

- ❑ The Greifswald Unit 1 was in service for 15 years
- ❑ Temperature at the core barrel: **265°C**
- ❑ Based on theoretical calculations the neutron flux ranges ($E > 1$ MeV) are:
 - 2.6×10^{17} n/m²s, i.e. $4.4 \cdot 10^{-8}$ dpa/s in position of RCI core baffle,
 - $6-9 \times 10^{16}$ n/m²s, i.e. $1-1.5 \cdot 10^{-8}$ dpa/s in position of RCI core shroud / basket,
 - $1.7-4.6 \times 10^{16}$ n/m²s in position of RCI **core barrel (3-7.8x10⁻⁹ dpa/s)**.

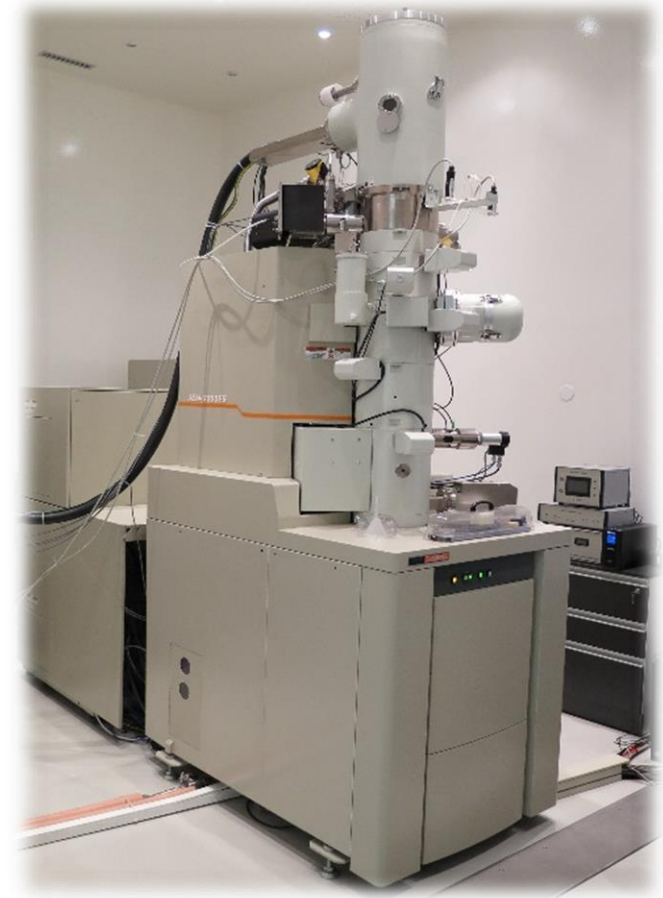
- ❑ CIEMAT and CVR collaboration
- ❑ Microscope at CVR facilities:
 - TEM JEOL JEM 2200FS
 - Electron source: Field Emission Gun (FEG)
 - Accelerating voltage: 200 kV
 - In-column Omega filter
 - CTEM, STEM
 - HAADF STEM detector for Z-contrast imaging
 - EDX detector 80 mm²
 - EELS

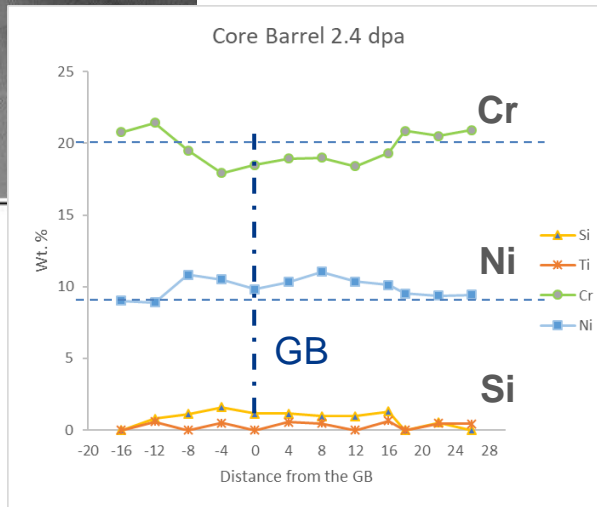
Core barrel 2.4 dpa, 265°C, $\sim 10^{-9}$ dpa/s Microchemistry: RIS at GB

Core barrel 2.4 dpa, 265°C, $\sim 10^{-9}$ dpa/s

- Grain boundary areas were investigated with focus on local chemical changes.
- Radiation-induced segregation of Cr, Ni, Si and Fe was observed across high-angle grain boundary using STEM EDS.
- The segregation of elements (depletion of Cr and enrichment of Ni, Si) is taking place in a region of about 20 nm.

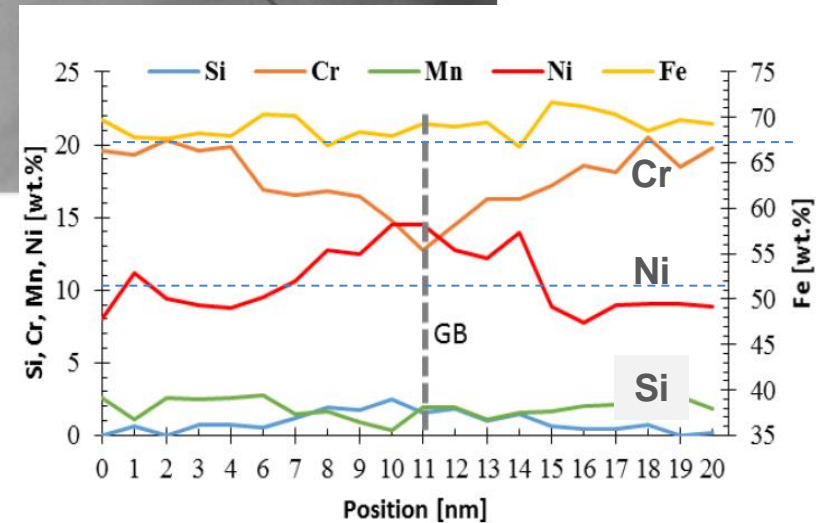
Core basket 5.2 dpa, 325°C, $\sim 10^{-8}$ dpa/s

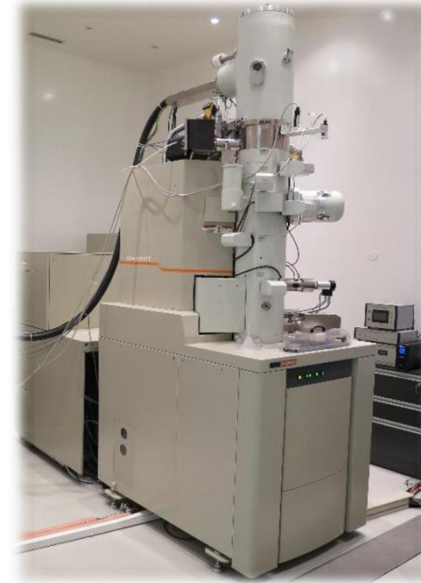
□ Microscope at CVR facilities:

- TEM JEOL JEM 2200FS
- Electron source: Field Emission Gun (FEG)
- Accelerating voltage: 200 kV
- In-column Omega filter
- CTEM, STEM
- HAADF STEM detector for Z-contrast imaging
- EDX detector 80 mm²
- EELS
- Gatan double-tilt heating holder

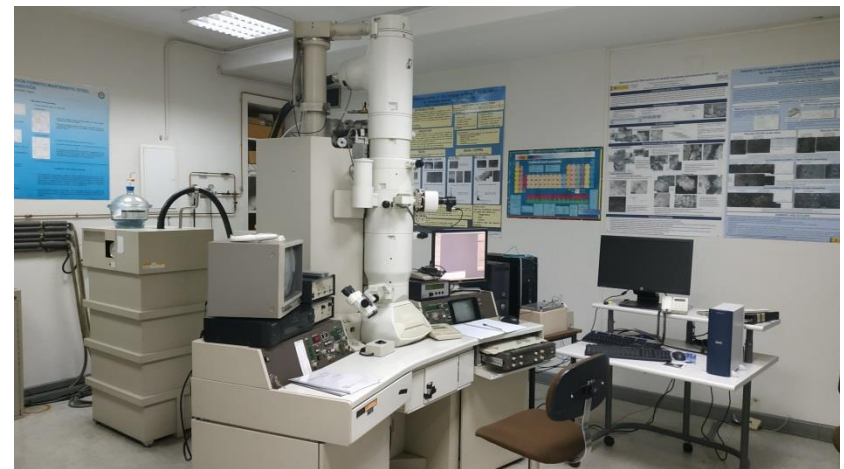
□ Microscope at CIEMAT facilities

- TEM JEOL JEM 2010
- LaB₆ filament
- Accelerating voltaje: 200 kV
- CTEM
- EDX detector 80 mm²
- Gatan double tilt heating holder
- Video recording

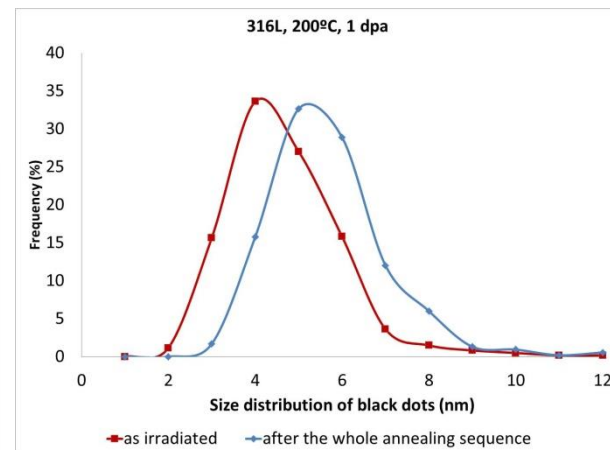
Size distribution of the black dots in the 316 steel as-irradiated at 200°C/1 dpa and after the whole annealing sequence.

- ❑ Disappearance of defects was observed to occur as a consequence of the annealing
- ❑ Changes in density or in size are not easy to follow during the experiments, but it is possible to provide information at the different steps of the annealing from the analysis of the video frames.
- ❑ A slight increase of the average size is observed and the size distribution is shifted towards larger sizes → the increase in size is due to the preferential disappearance of the smaller defects or black dots and not to actual growth.
- ❑ “Since the black dots showed slightly faster recovery during PIA than the dislocation loops, the black dots may contain some fraction of thermal unstable clusters, which might be vacancy type” (Fukuya et al.)
